Preliminary Damage Report of the August 22, 2011 Mw 5.3 Earthquake near Trinidad, Colorado

Matthew L. Morgan and Karen S. Morgan

Colorado Geological Survey

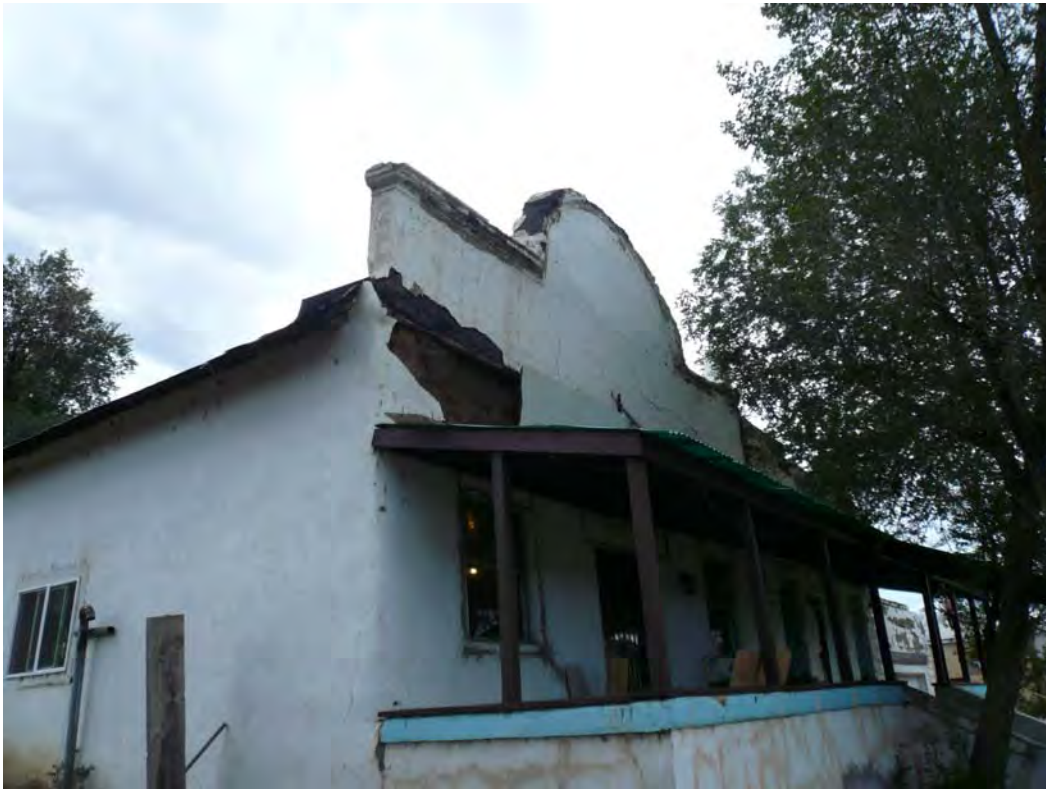
An adobe building from early 20th century had its front façade displaced horizontally. Part of the façade crumbled and adobe fragments were scattered on the front porch roof (Figure 1). Two-foot-long rock blocks from the façade fell 10 feet through the front porch roof (Figure 2). The front wall of the building moved 1" horizontally (north) (Figure 3). The floor within the house dropped 1-2" as measured from the base of the internal doors that closed before the event. The floor was visibly heaved and down-dropped in areas. 6-foot-high bookcases within the house were knocked over (Figure 4) and cupboards were left in shambles (Figure 5). The resident reported being thrown onto his wife while sleeping. Damage to the outside walls was clearly visible as cracks and missing plaster (Figure 6). In the backyard, the fence was displaced 2 feet horizontally (S-N). The outside chimney was displaced 2" (Figure 7). The local fire department recommended the residents evacuate the house until it could be reviewed for structural damage.

Figure 1. Highly damaged residence in Segundo where the façade has crumbled and pulled away from the main structure.

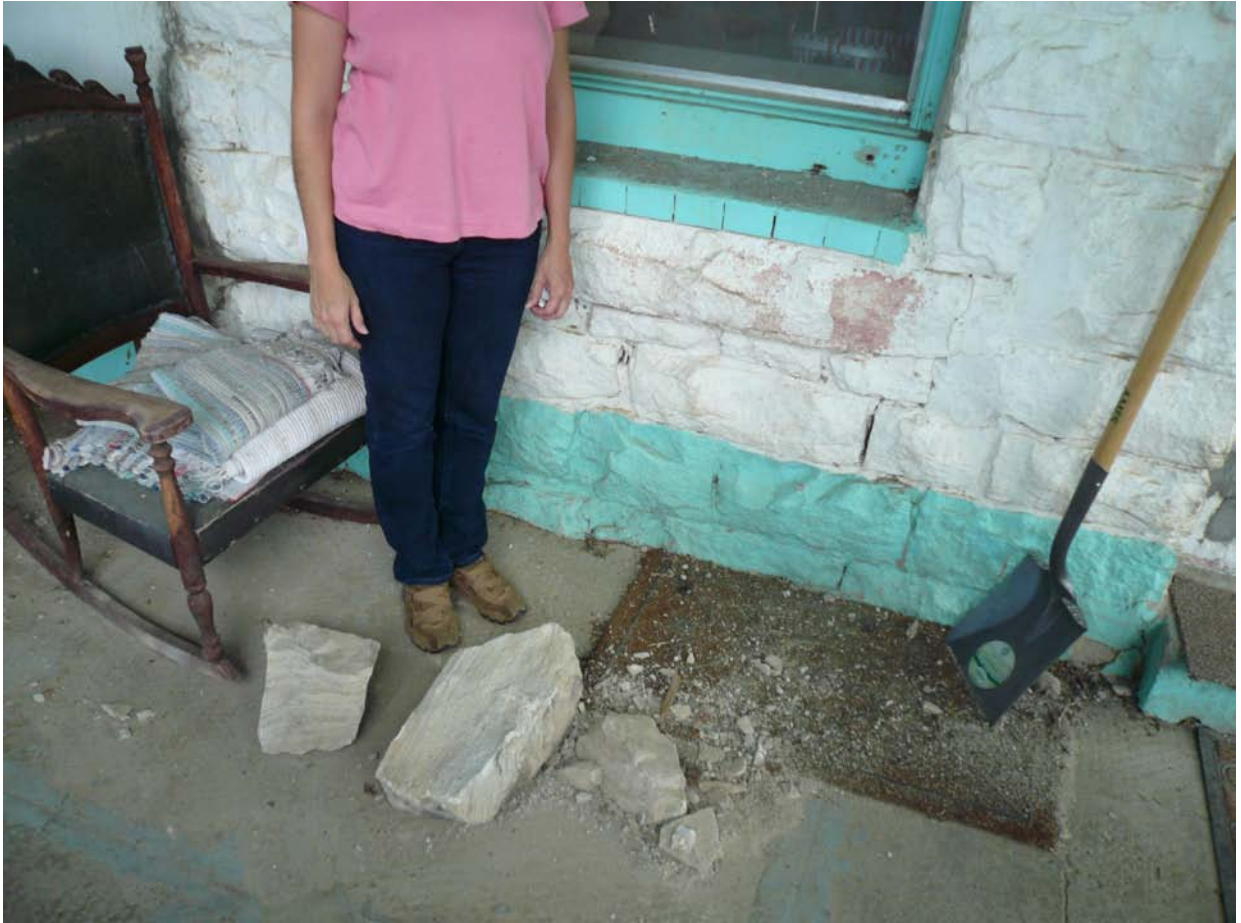
Figure 2. Two-foot-long rock blocks from the façade that fell 10 feet through the front porch roof. Segundo, CO.

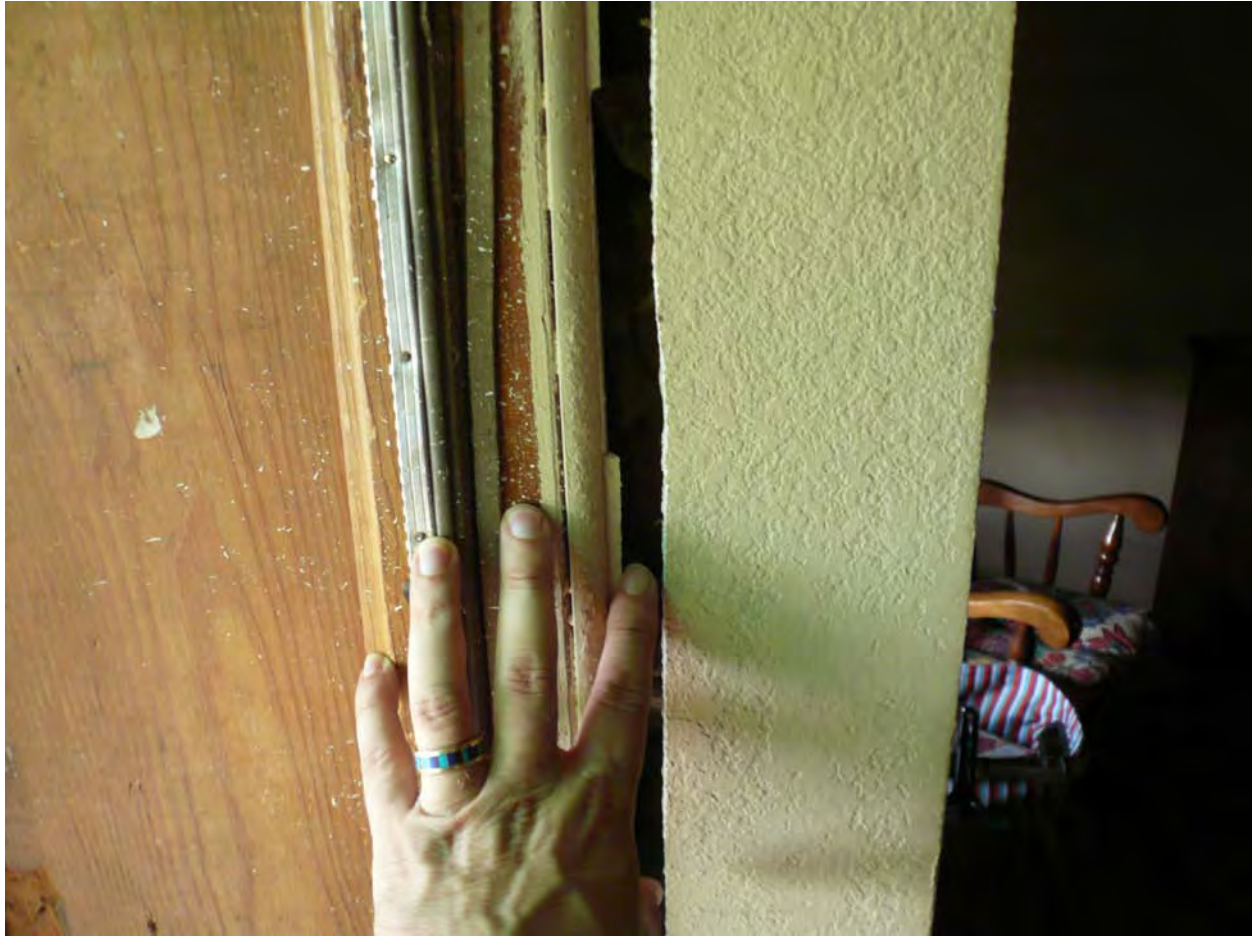
Figure 3. The exterior wall pulled away approximately 1" from the interior wall. Segundo, CO.

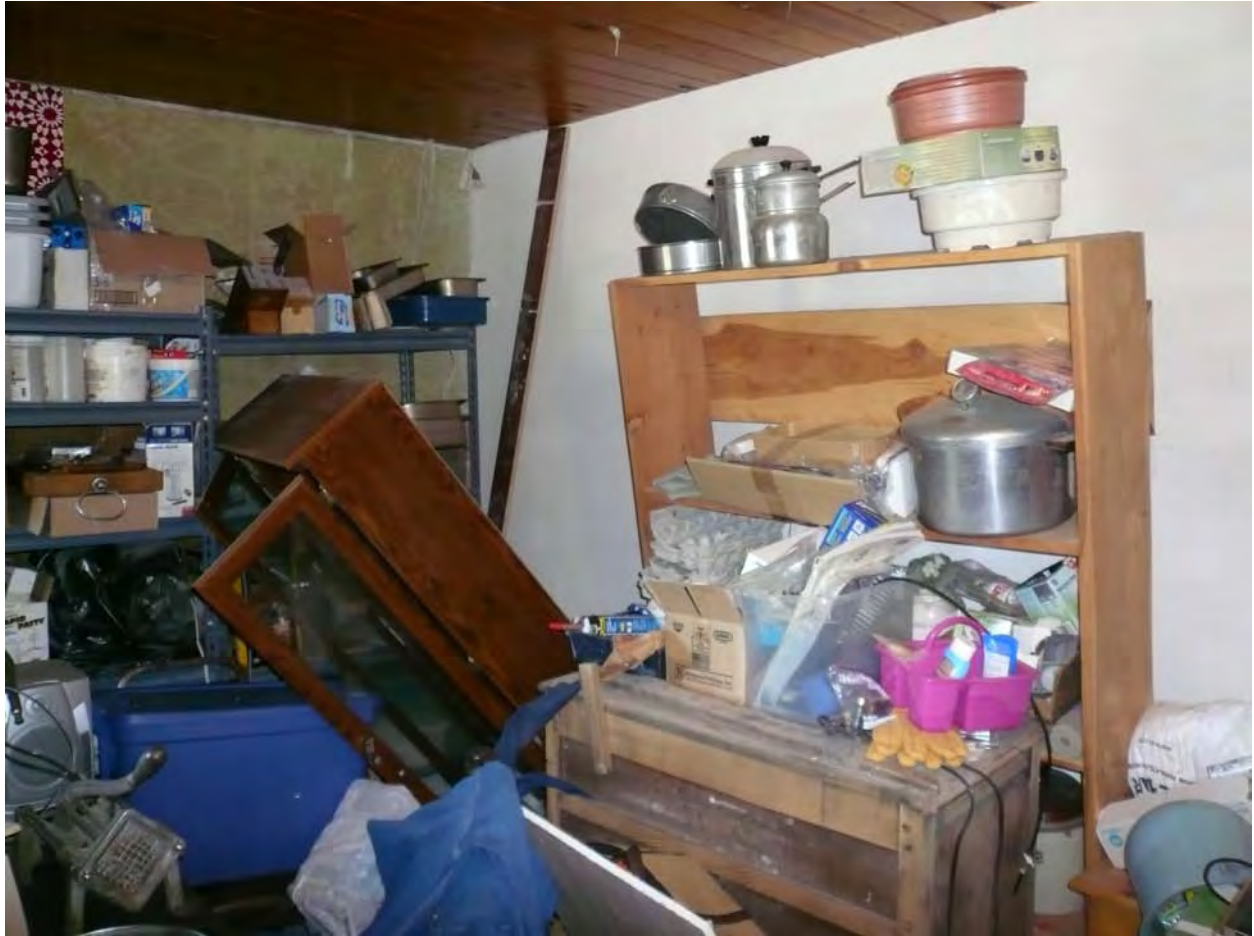
Figure 4. Large bookcases were toppled over from the shaking. The resident reported S-N movement. Segundo, CO.

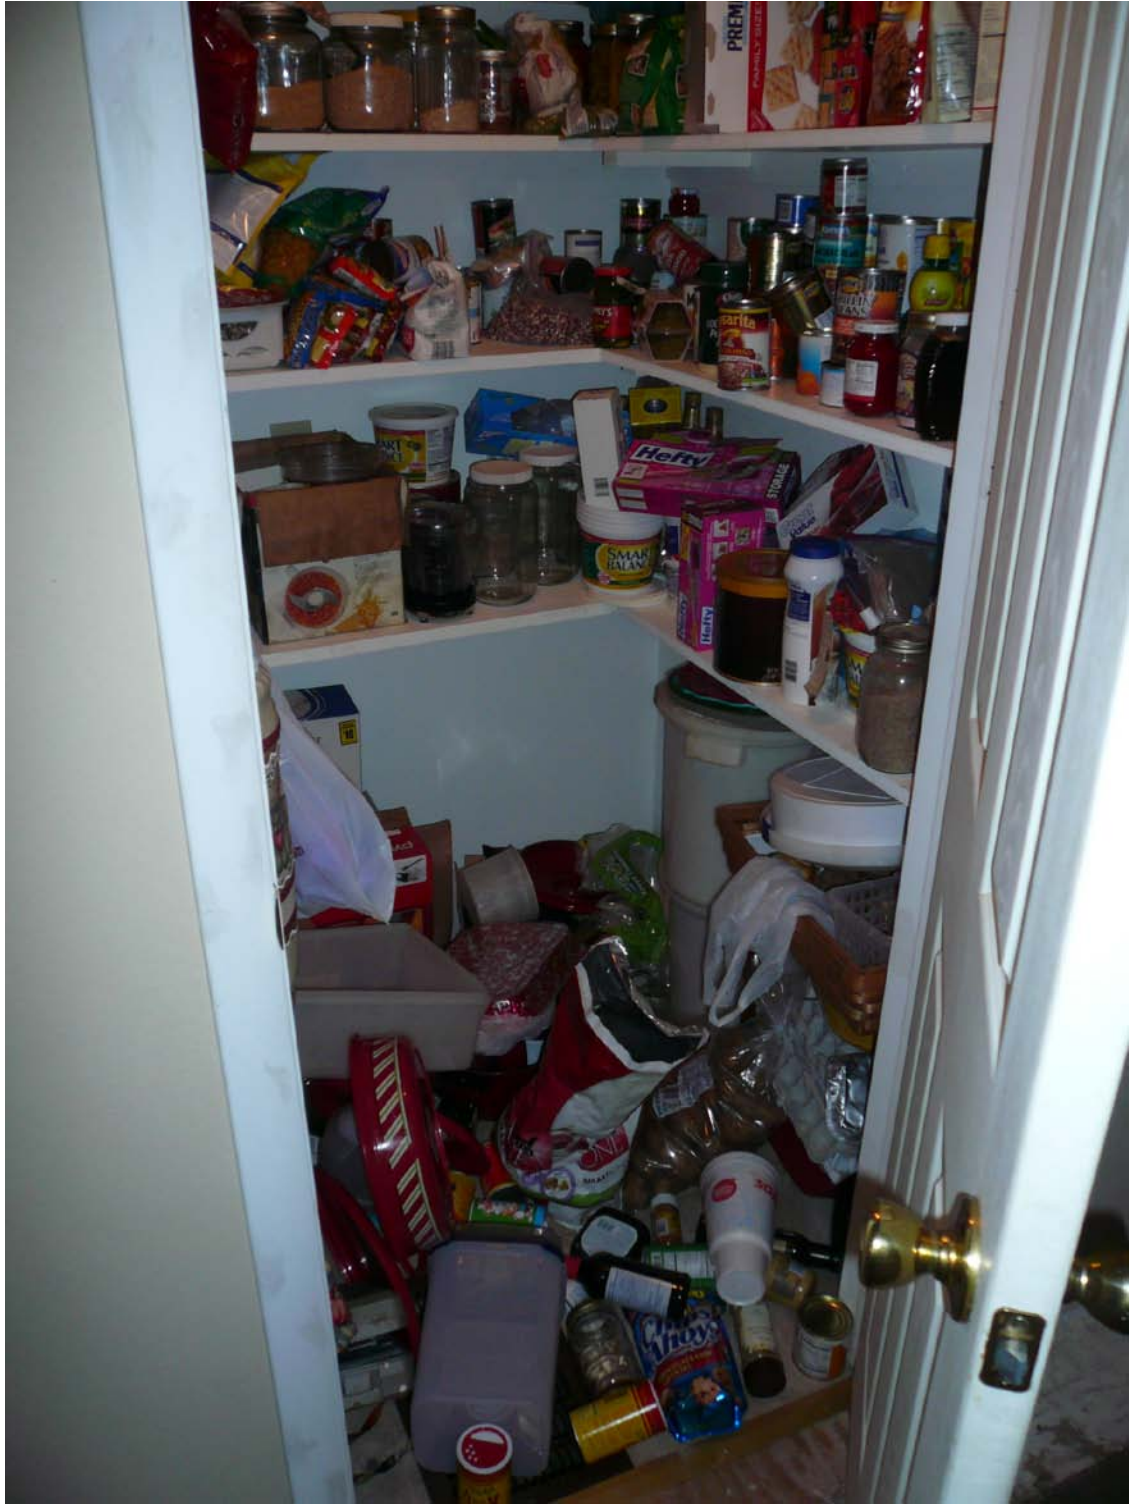
Figure 5. Cupboard contents thrown from the shelves. Segundo, CO.

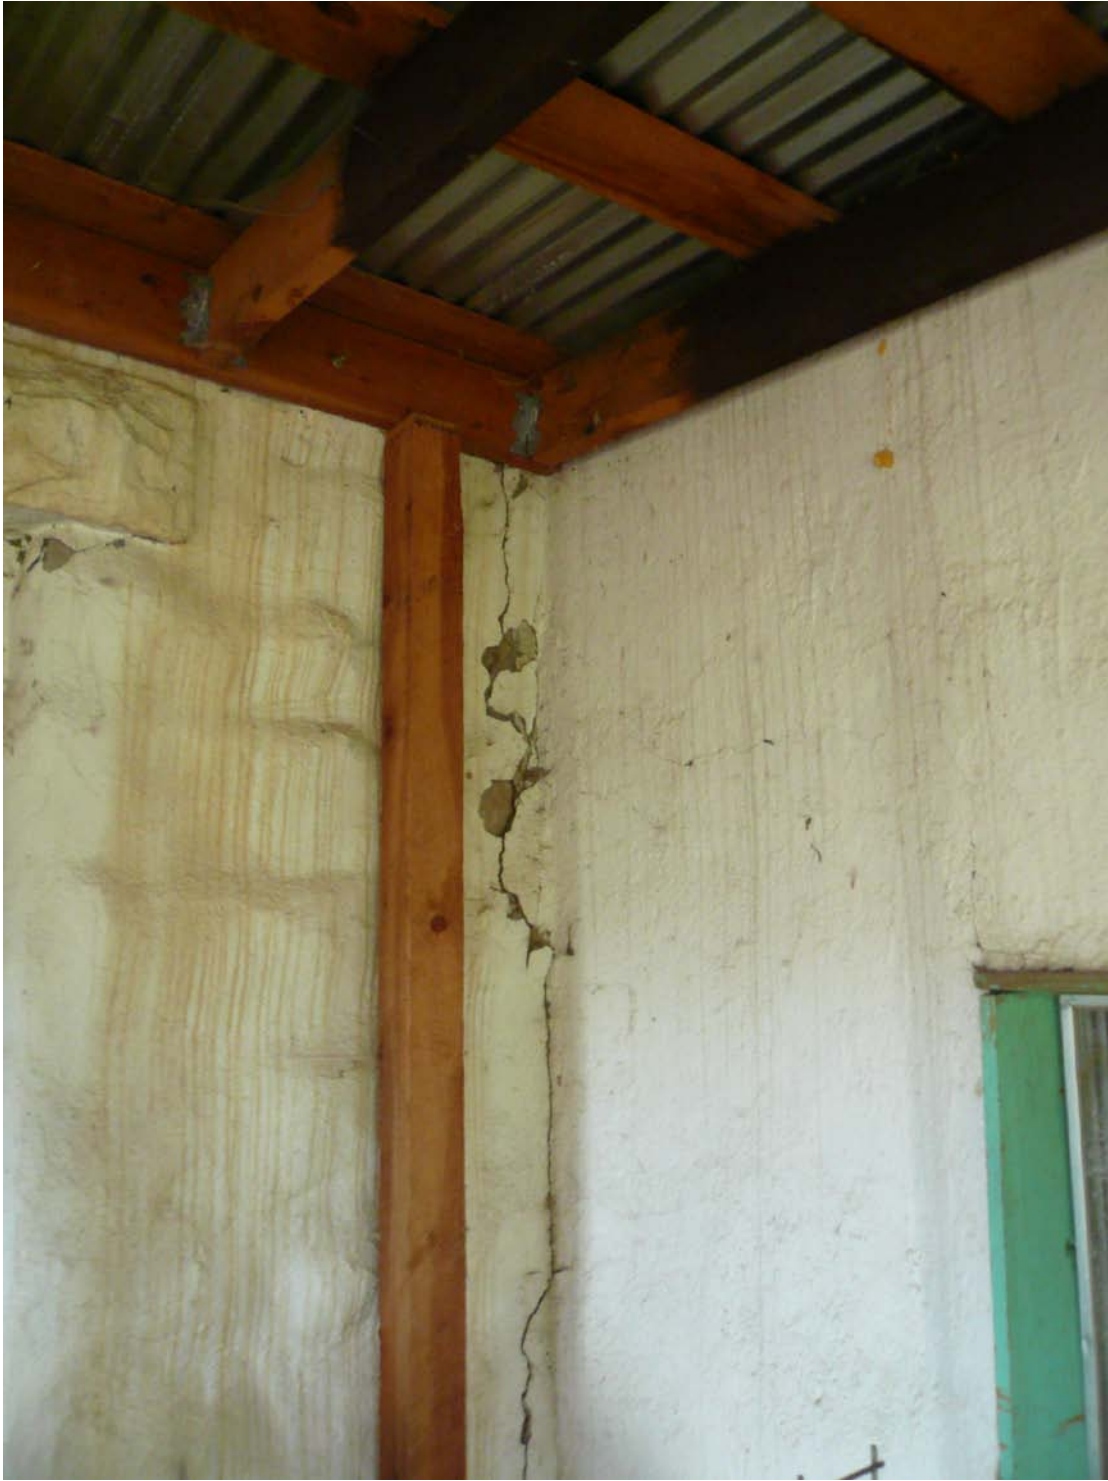
Figure 6. Cracked and missing plaster was pervasive. Segundo, CO.

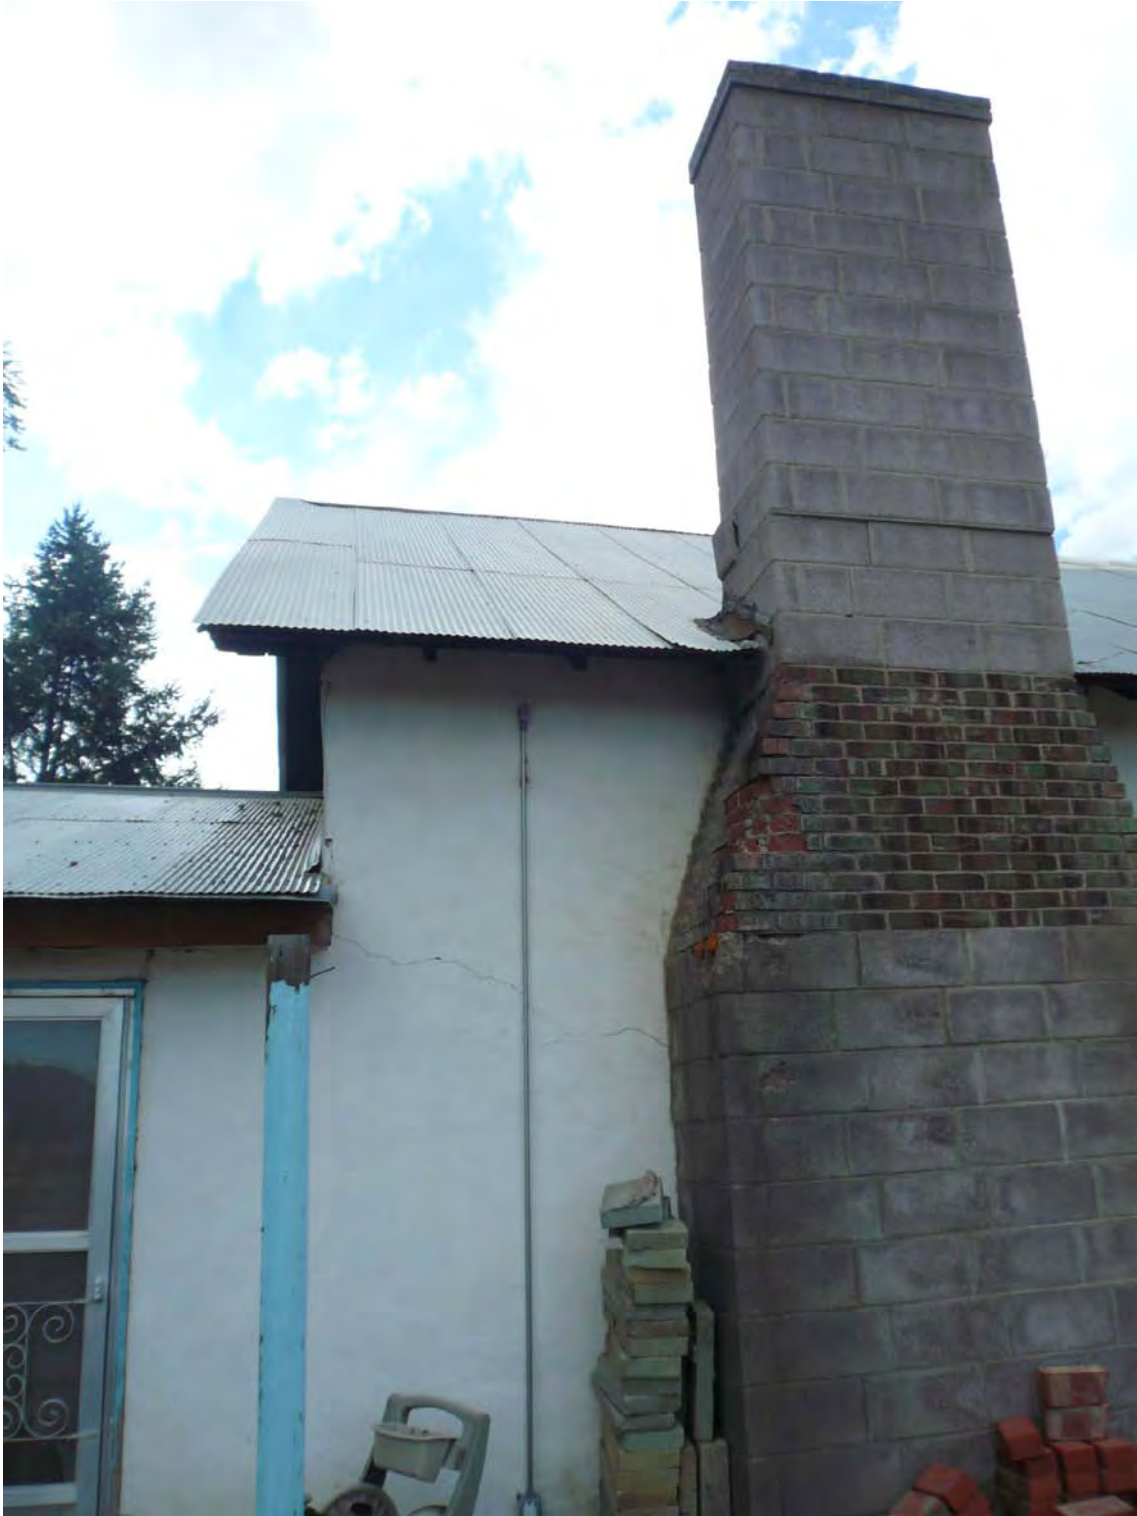
Figure 7. Chimney displaced approximately 2". Segundo, CO.

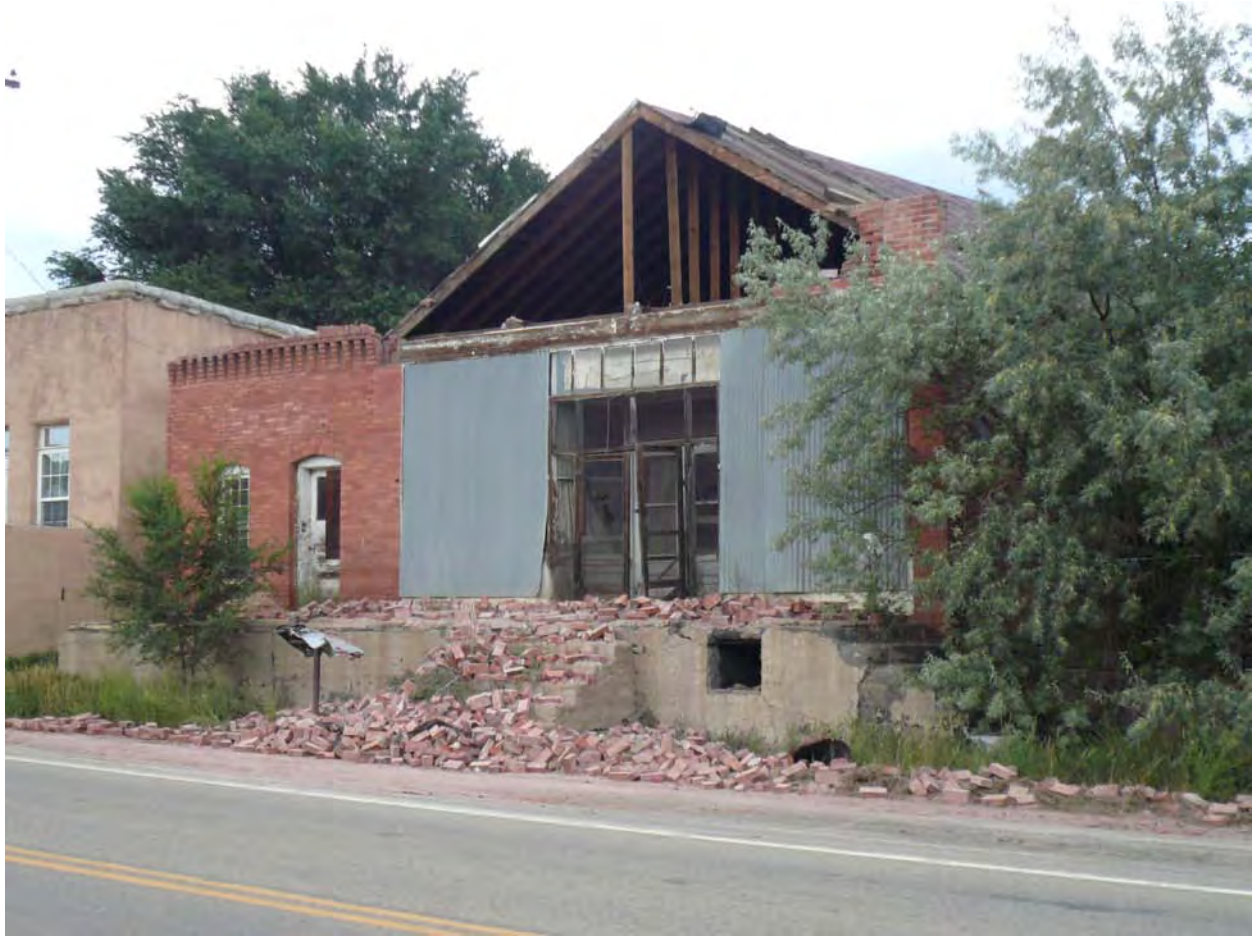
On State Highway 12, the front of an early 20th century brick building collapsed. Numerous bricks spilled onto the highway (Figure 8). The resident's mailbox was crushed by the falling debris. Nearby, a chimney was toppled and bricks were tossed onto the highway (Figure 9).

Figure 8. The front of this brick building collapsed, sending debris onto State Highway 12. Note the crushed mailbox. Segundo, CO.

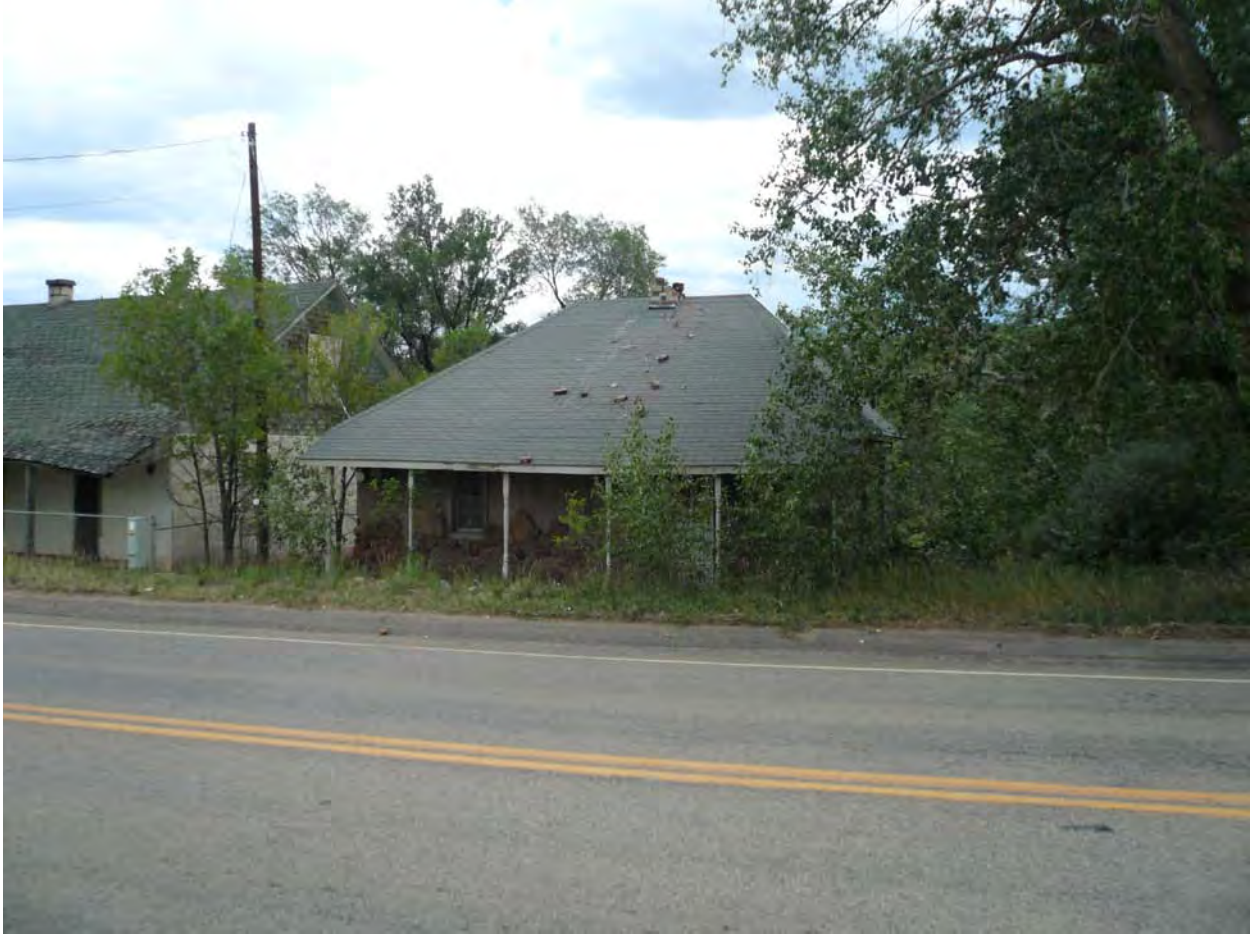
Figure 9. The earthquake toppled this chimney sending a few bricks onto State Highway 12. Segundo, CO.

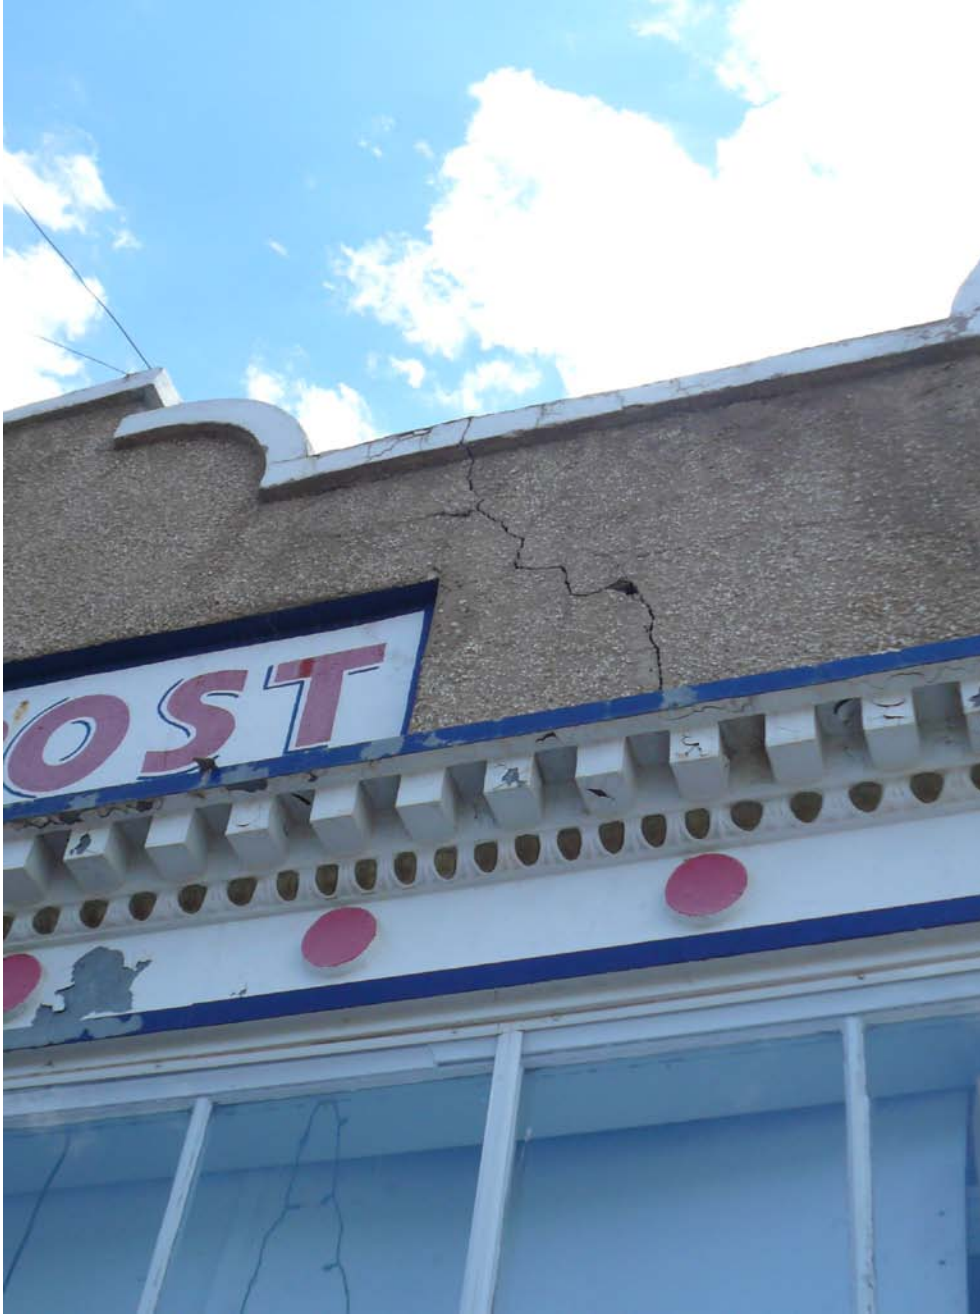
Liquor bottles in Ringo's Market were thrown from the shelves. Cracked plaster inside and outside of the building was evident (Figure 10). The clerk reported "collector-style" decanters were thrown from shelves and shattered.

Figure 10. Cracked plaster on Ringo's Market in Segundo, CO. All of the liquor bottles inside were thrown to the floor and walls were cracked.

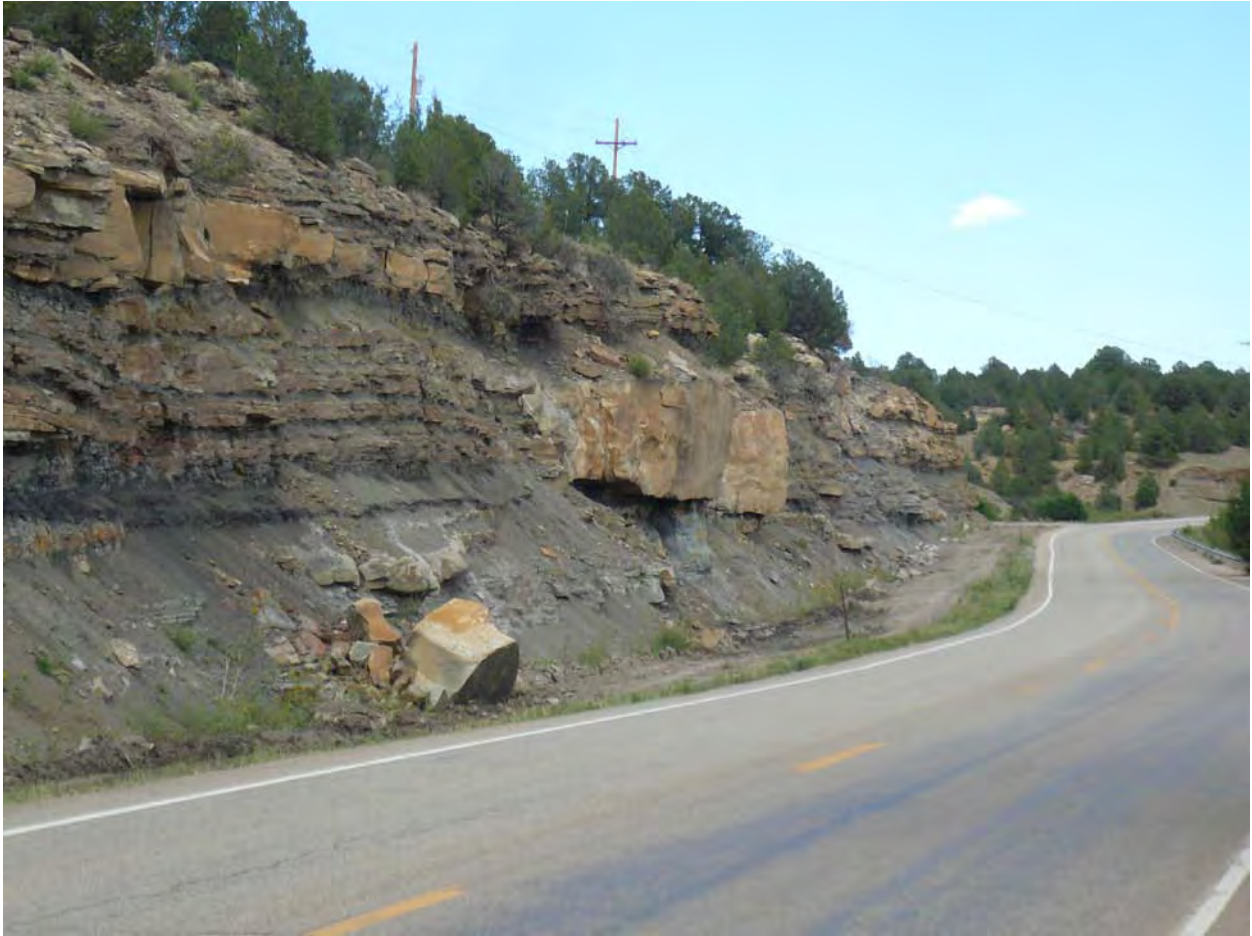
Rockfalls covered State Highway 12 approximately 1 mile east of Segundo-Valdez. These were quickly removed from the highway by CDOT. Large rock fragments were in excess of 6 feet (Figure 11).

Figure 11. Rockfall events along Highway 12, east of Valdez, temporarily closed the highway. Some boulders were in excess of 6 feet across. CDOT quickly cleaned up the roadway.

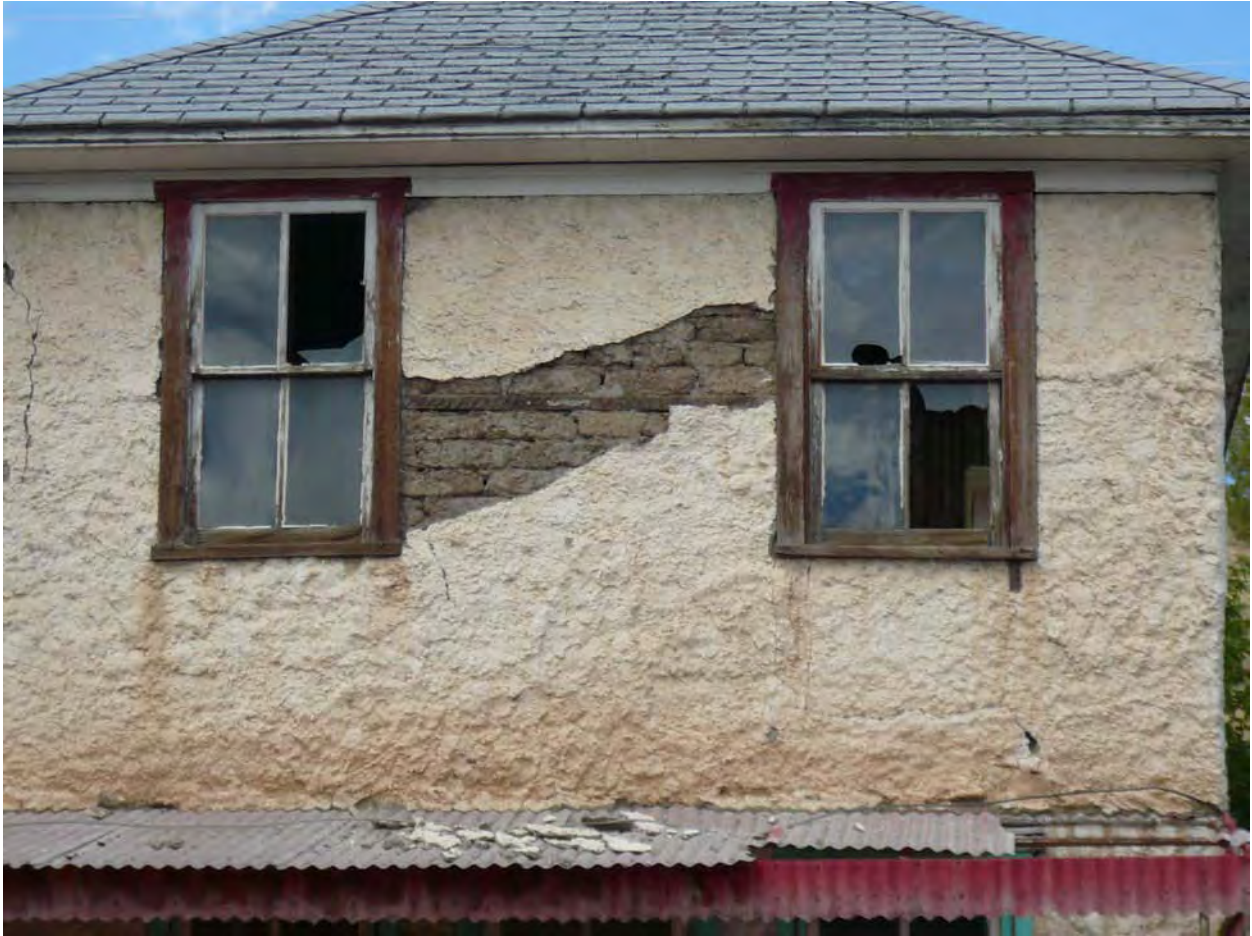
Several residents had plaster and brick damage ; internal chimneys were pulled from the walls (Figures 12, 13, 14). Glassware, pictures, and other wall displays were thrown onto the floor. A paneled roof collapsed in one residence (Figure 15). Chimneys were displaced.

Figure 12. An old adobe building in Segundo with cracked and displaced plaster.

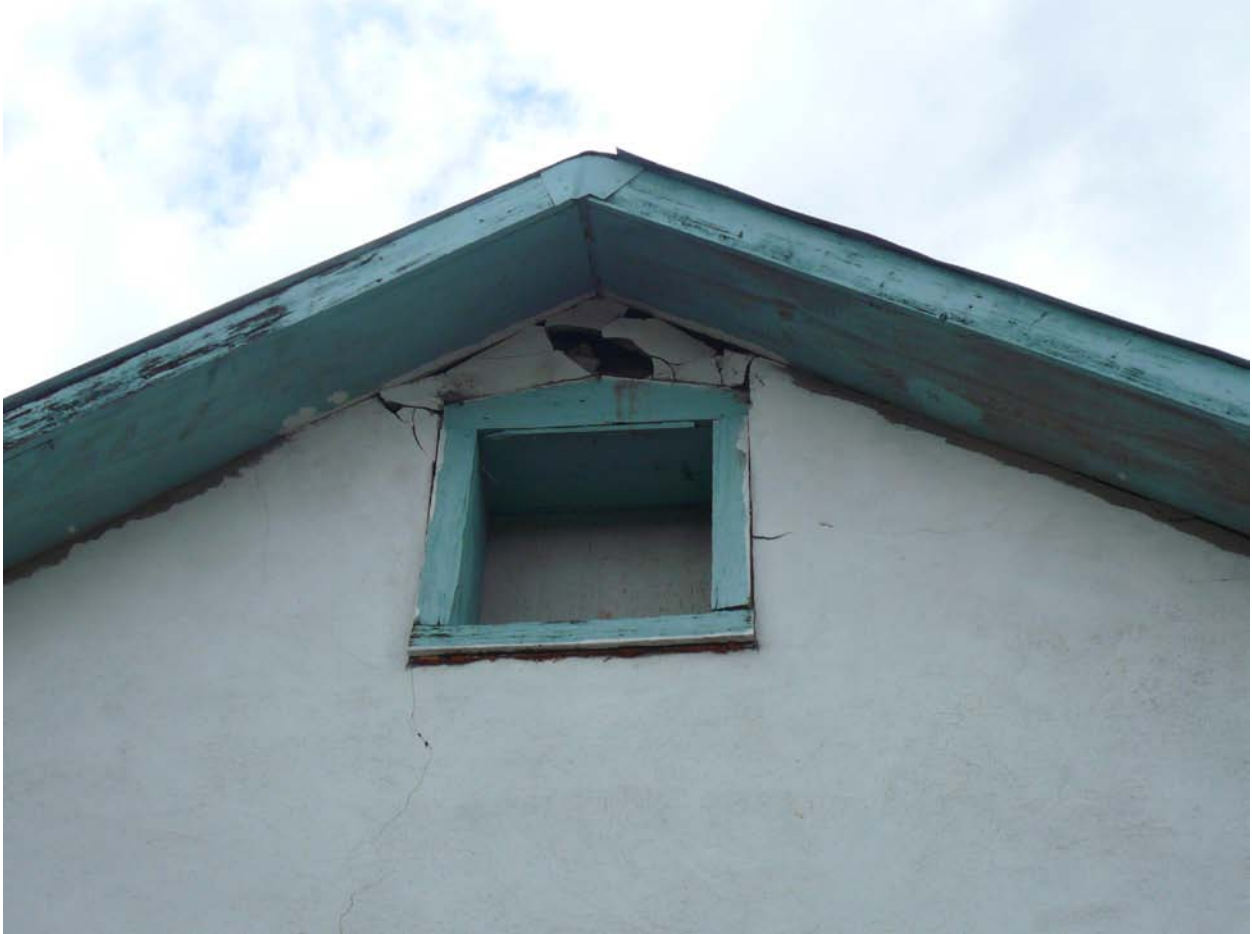
Figure 13. Major plaster and brick damage to a home in Segundo, CO.

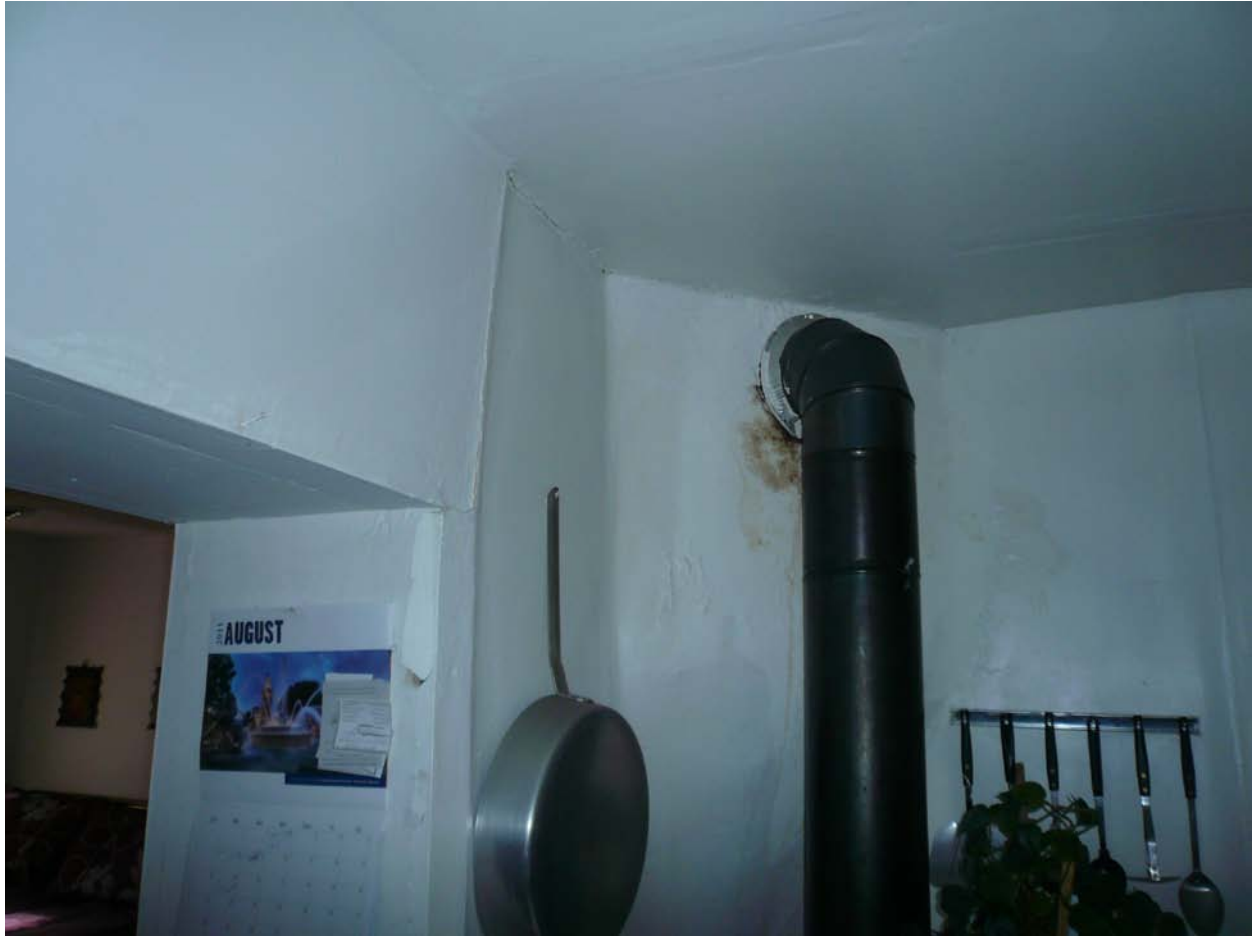
Figure 14. Chimney from a stove was pulled from the wall. Segundo, CO.

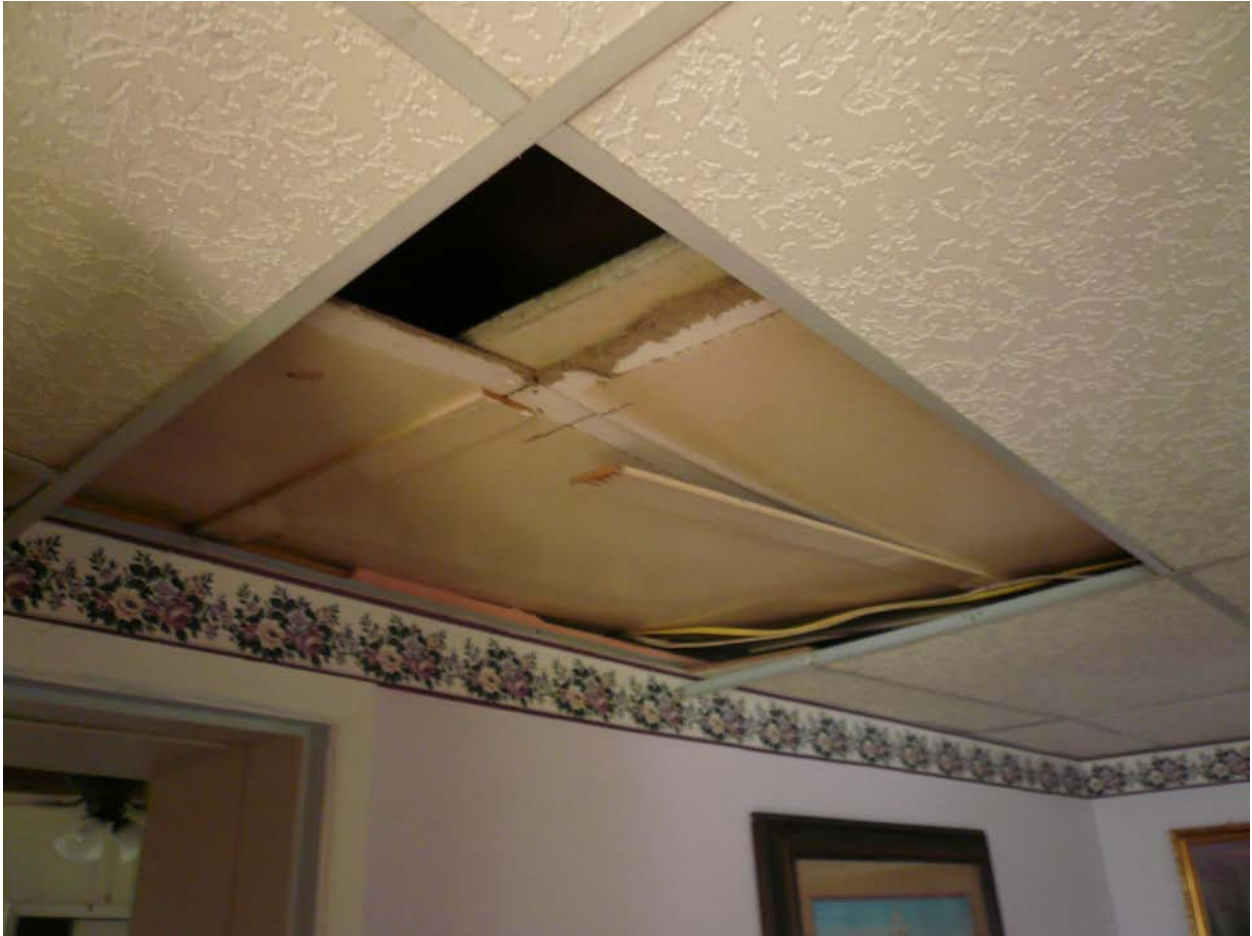
Figure 15. A ceiling panel collapsed sending debris on the resident's bed. Segundo, CO.

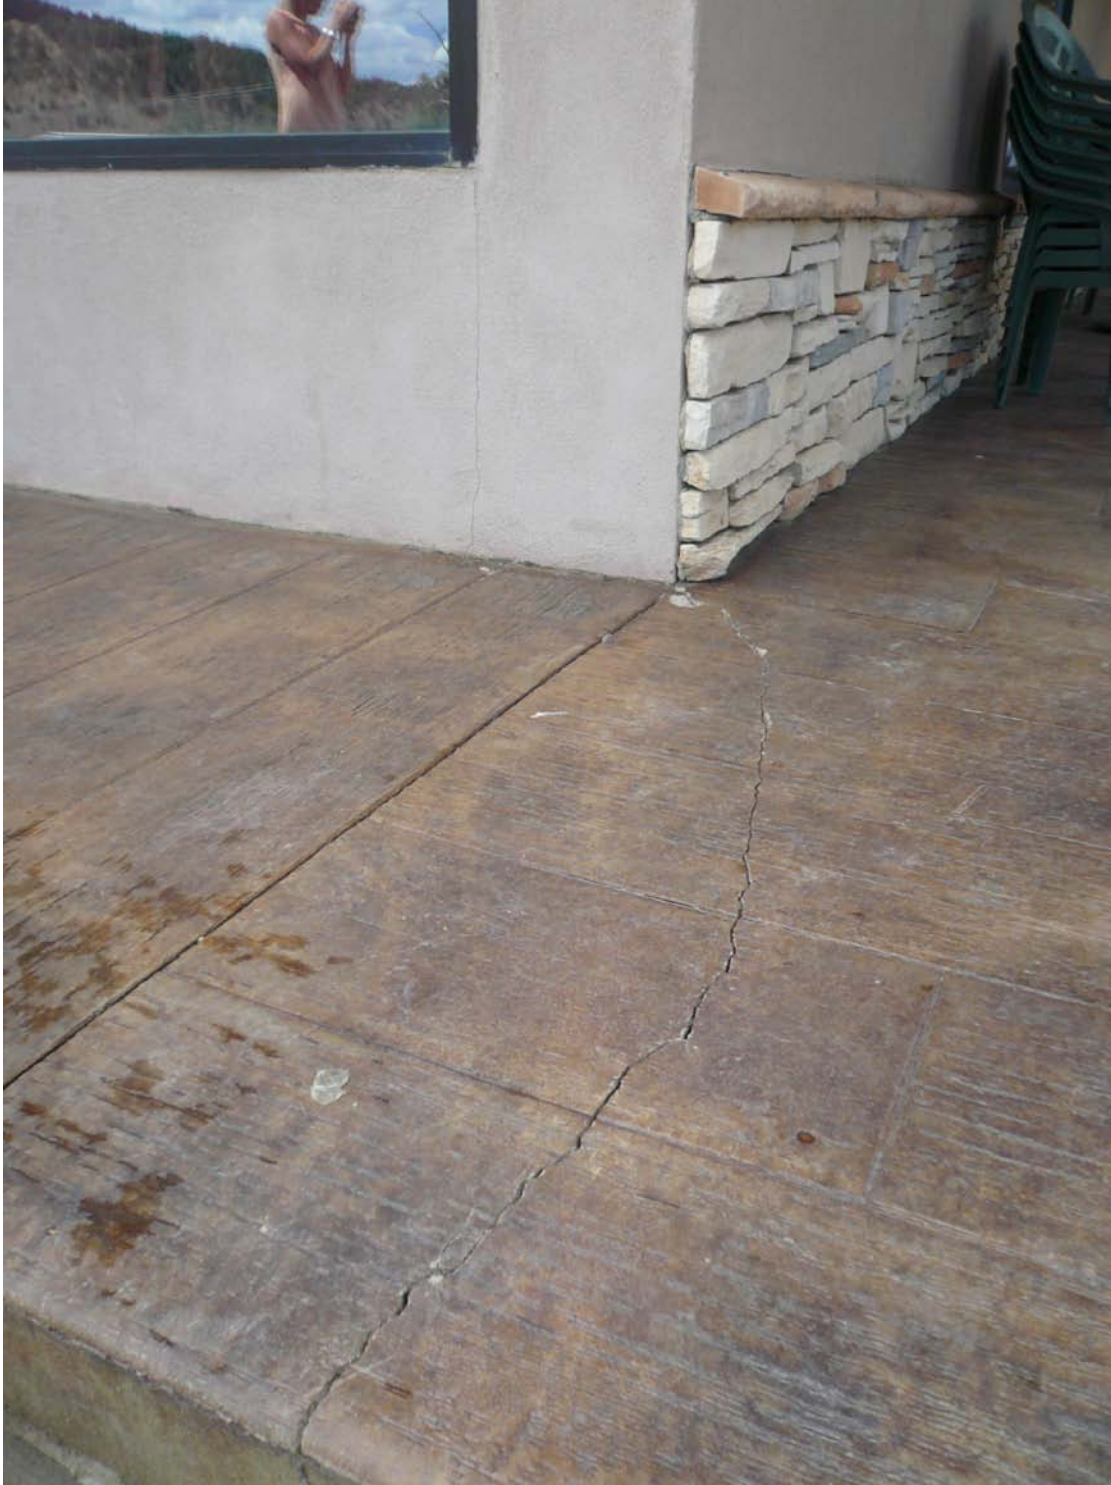
The Big 4 General Store, built in 2006, had a 5-foot-long crack in the porch pavement that had approximately 0.5” of offset (Figure 16). The east side of the building had a 7-foot-long horizontal crack in the plaster (Figure 17).

Figure 16. A five-foot-long crack in the concrete at the Big 4 Country Store in Valdez, CO.

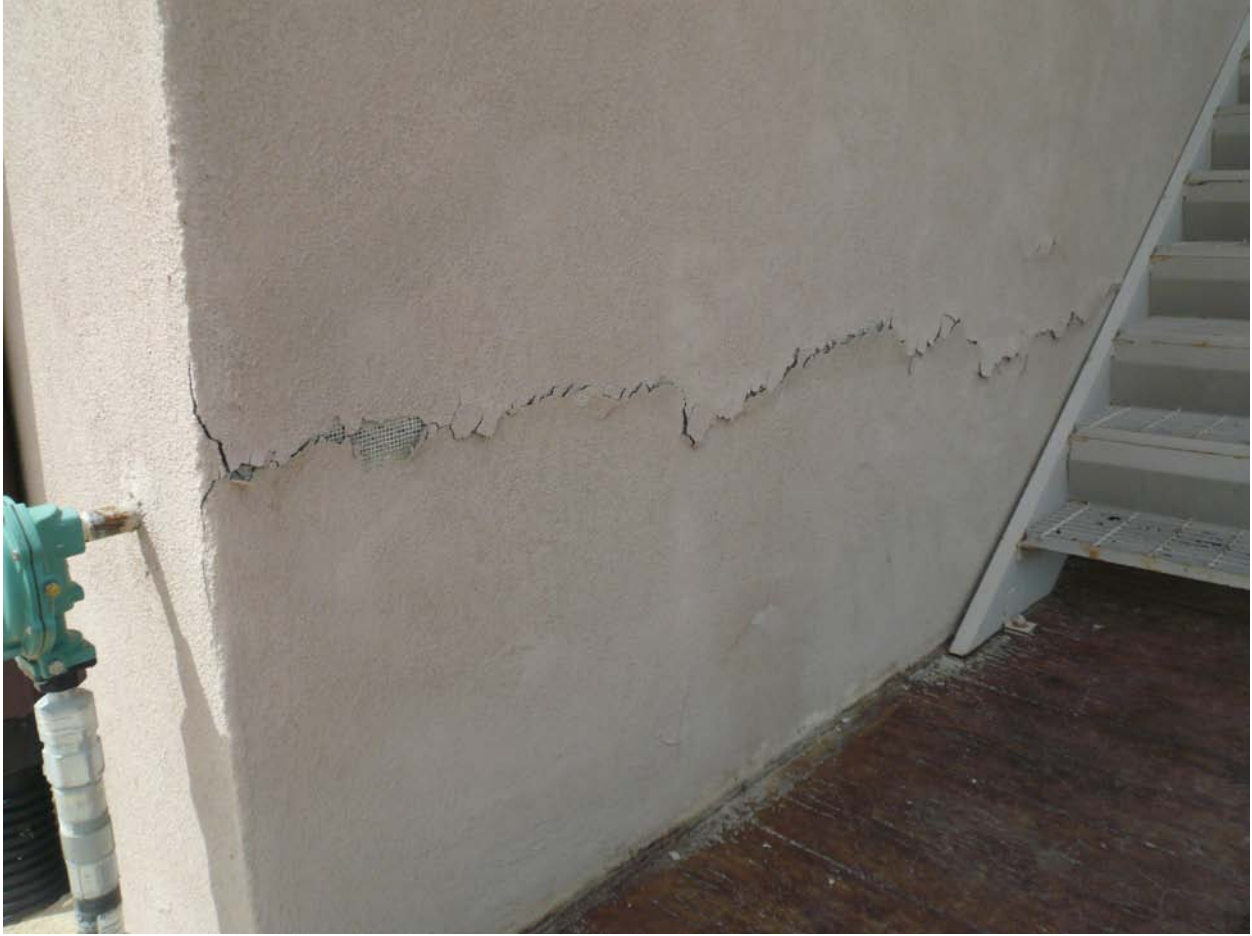
Figure 17. Cracked plaster at the Big 4 Country Store in Valdez, CO.
