Preliminary Damage Report of the August 22, 2011 Mw 5.3 Earthquake near Trinidad, Colorado

Matthew L. Morgan and Karen S. Morgan

Colorado Geological Survey

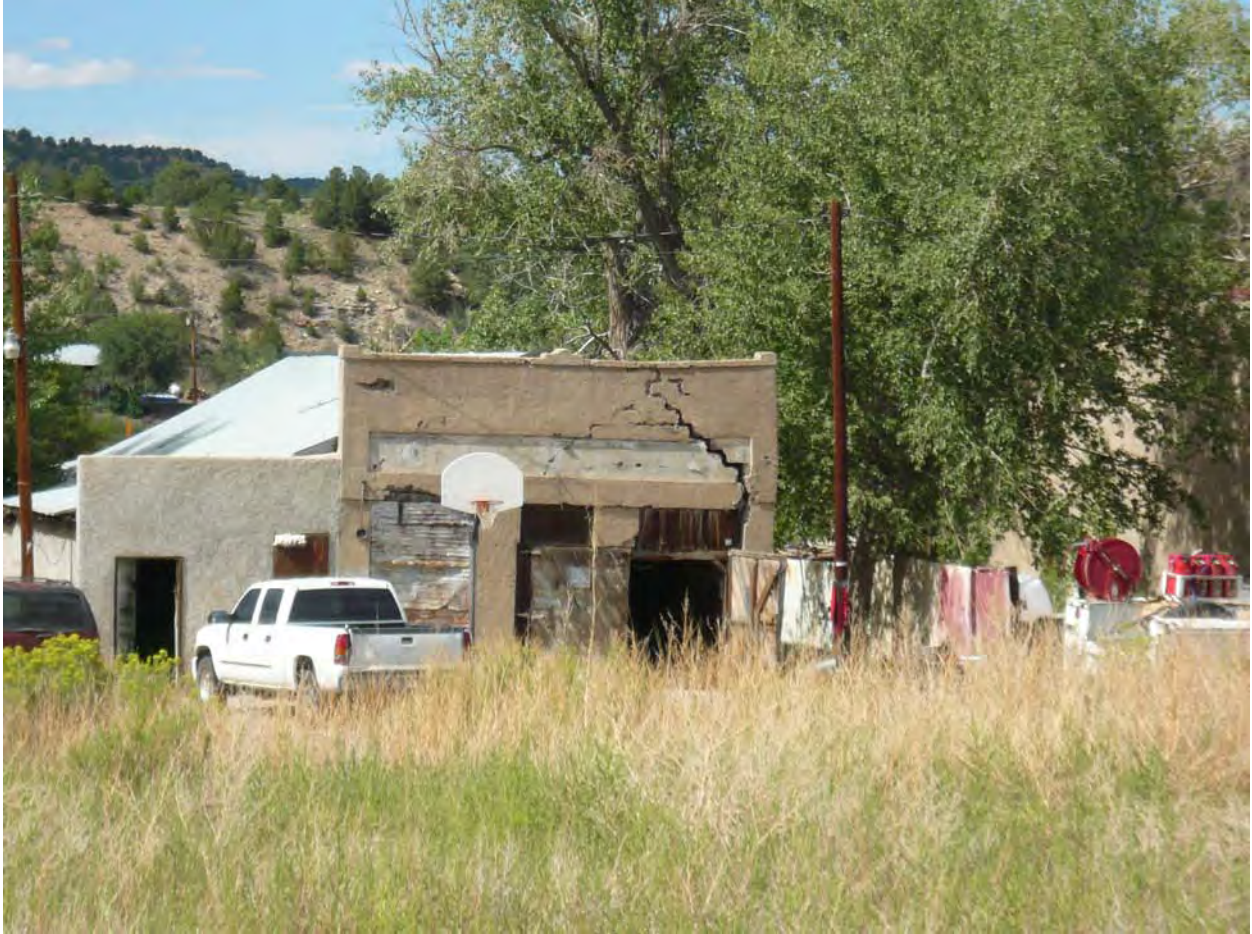
Several buildings had cracked plaster and damaged brickwork (Figure 18).

Figure 18. A severely damaged garage in Valdez, CO.

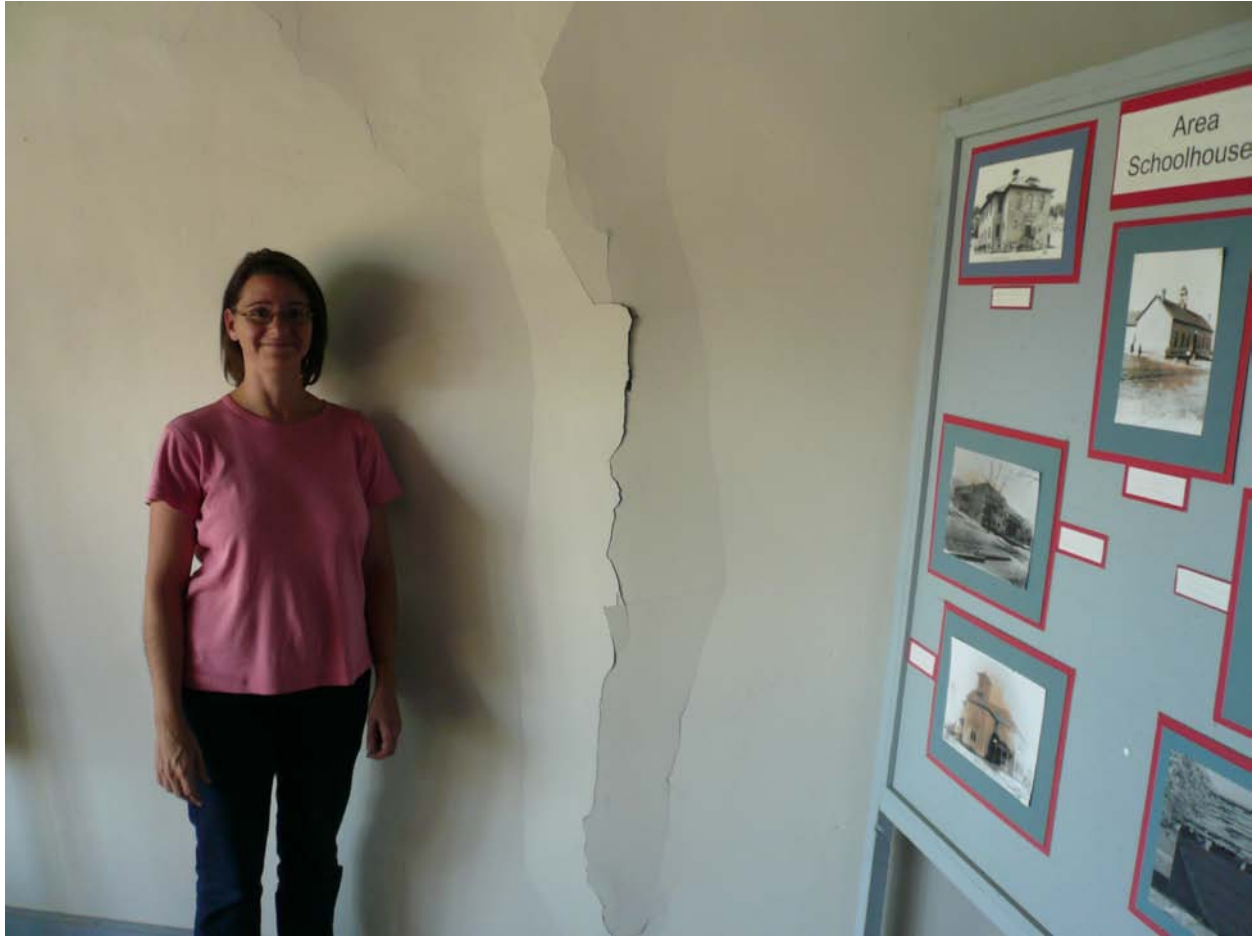
The town mayor reported “no significant damage to” the residences in the area. However, she reported a few pieces of glassware fell to the floor and cabinet doors rattled. The post office/town hall had a 10-foot-long vertical crack that buckled 2” from the face of the wall (Figure 19, 20). The crack was visible internally and externally. A 10” fragment of plaster was missing from the crack on the outside of the building (Figure 21).

Figure 19. A 10 foot long vertical crack in the upstairs floor of the Cokedale post office/city hall.

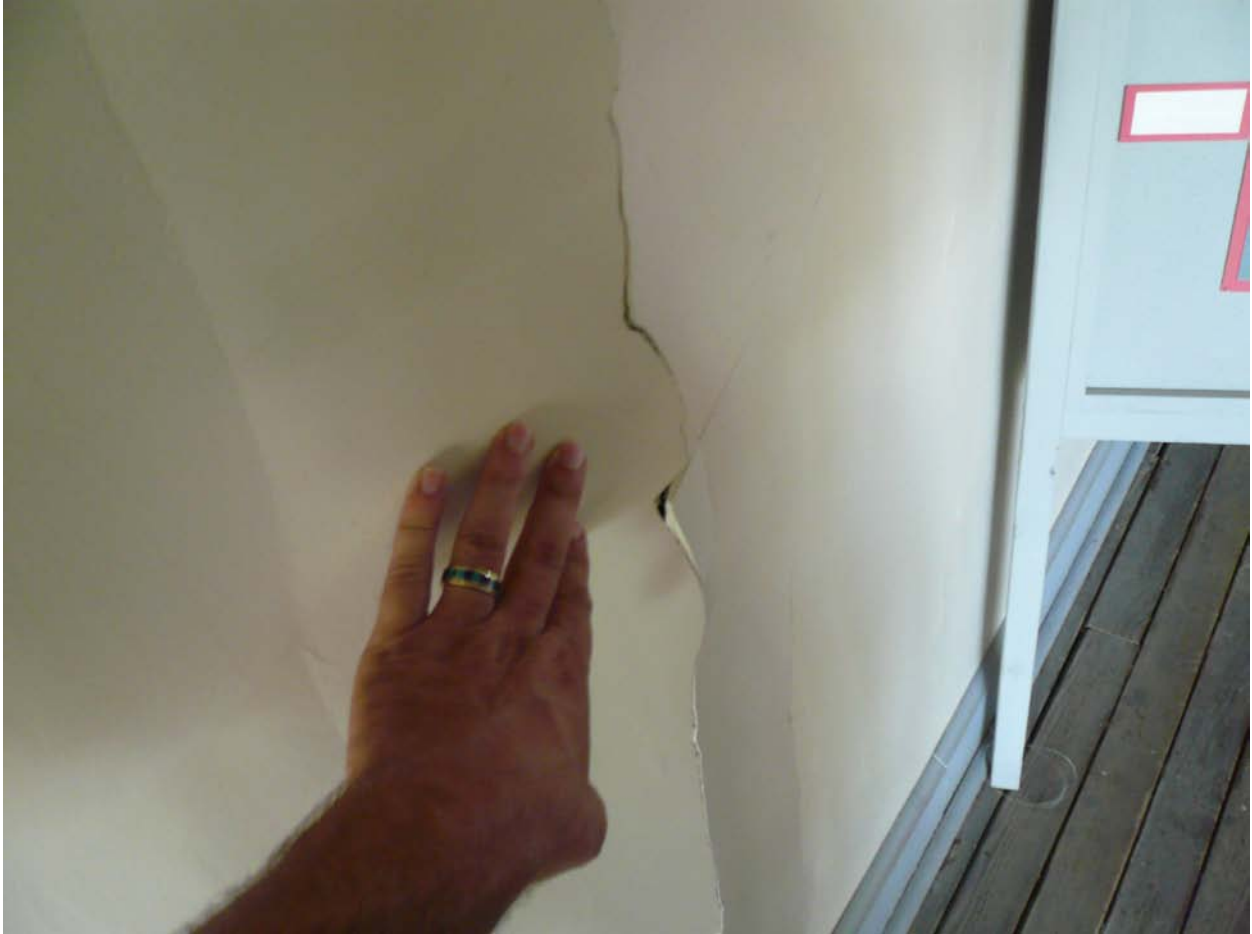
Figure 20. A few inches of buckling along the same crack in Figure 19. Cokedale, CO.

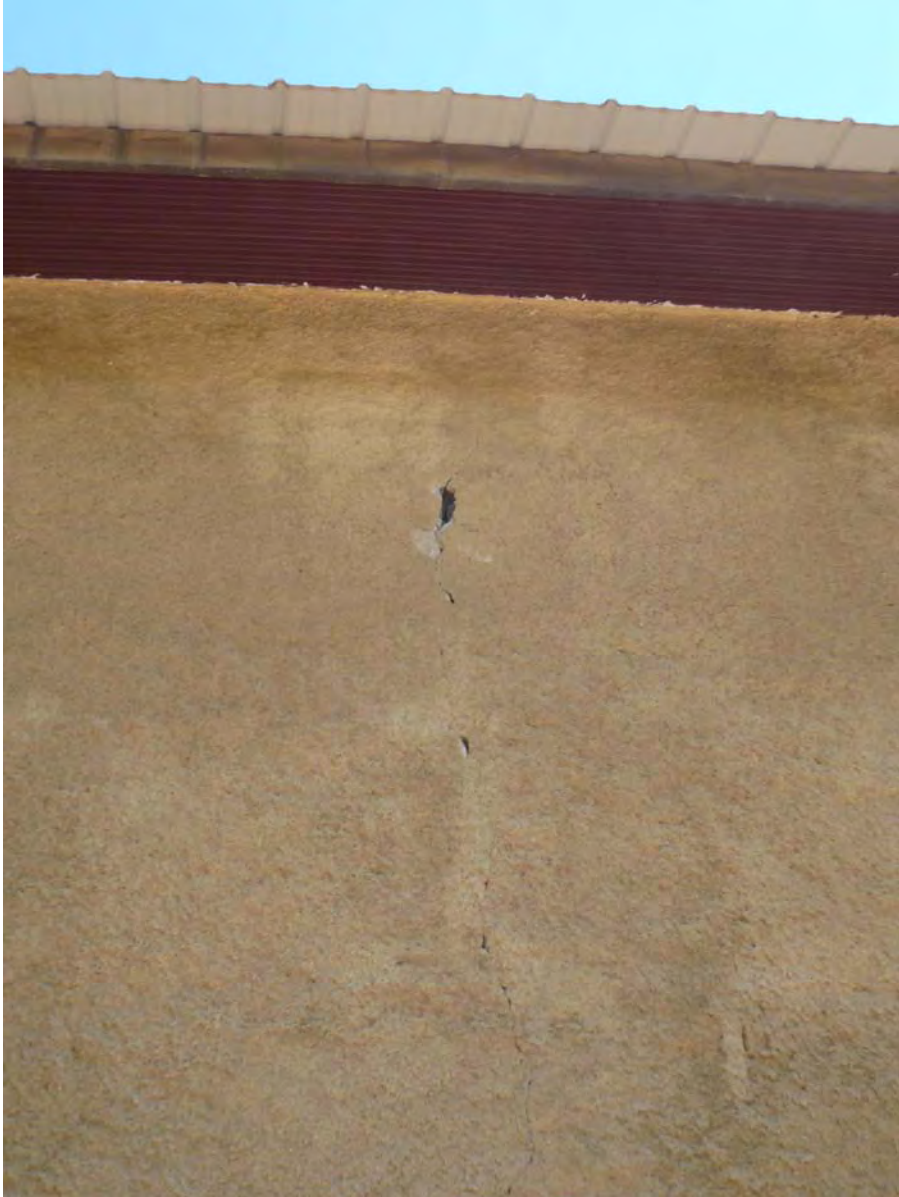
Figure 21. A large piece of plaster missing from an external crack on the Cokedale post office.

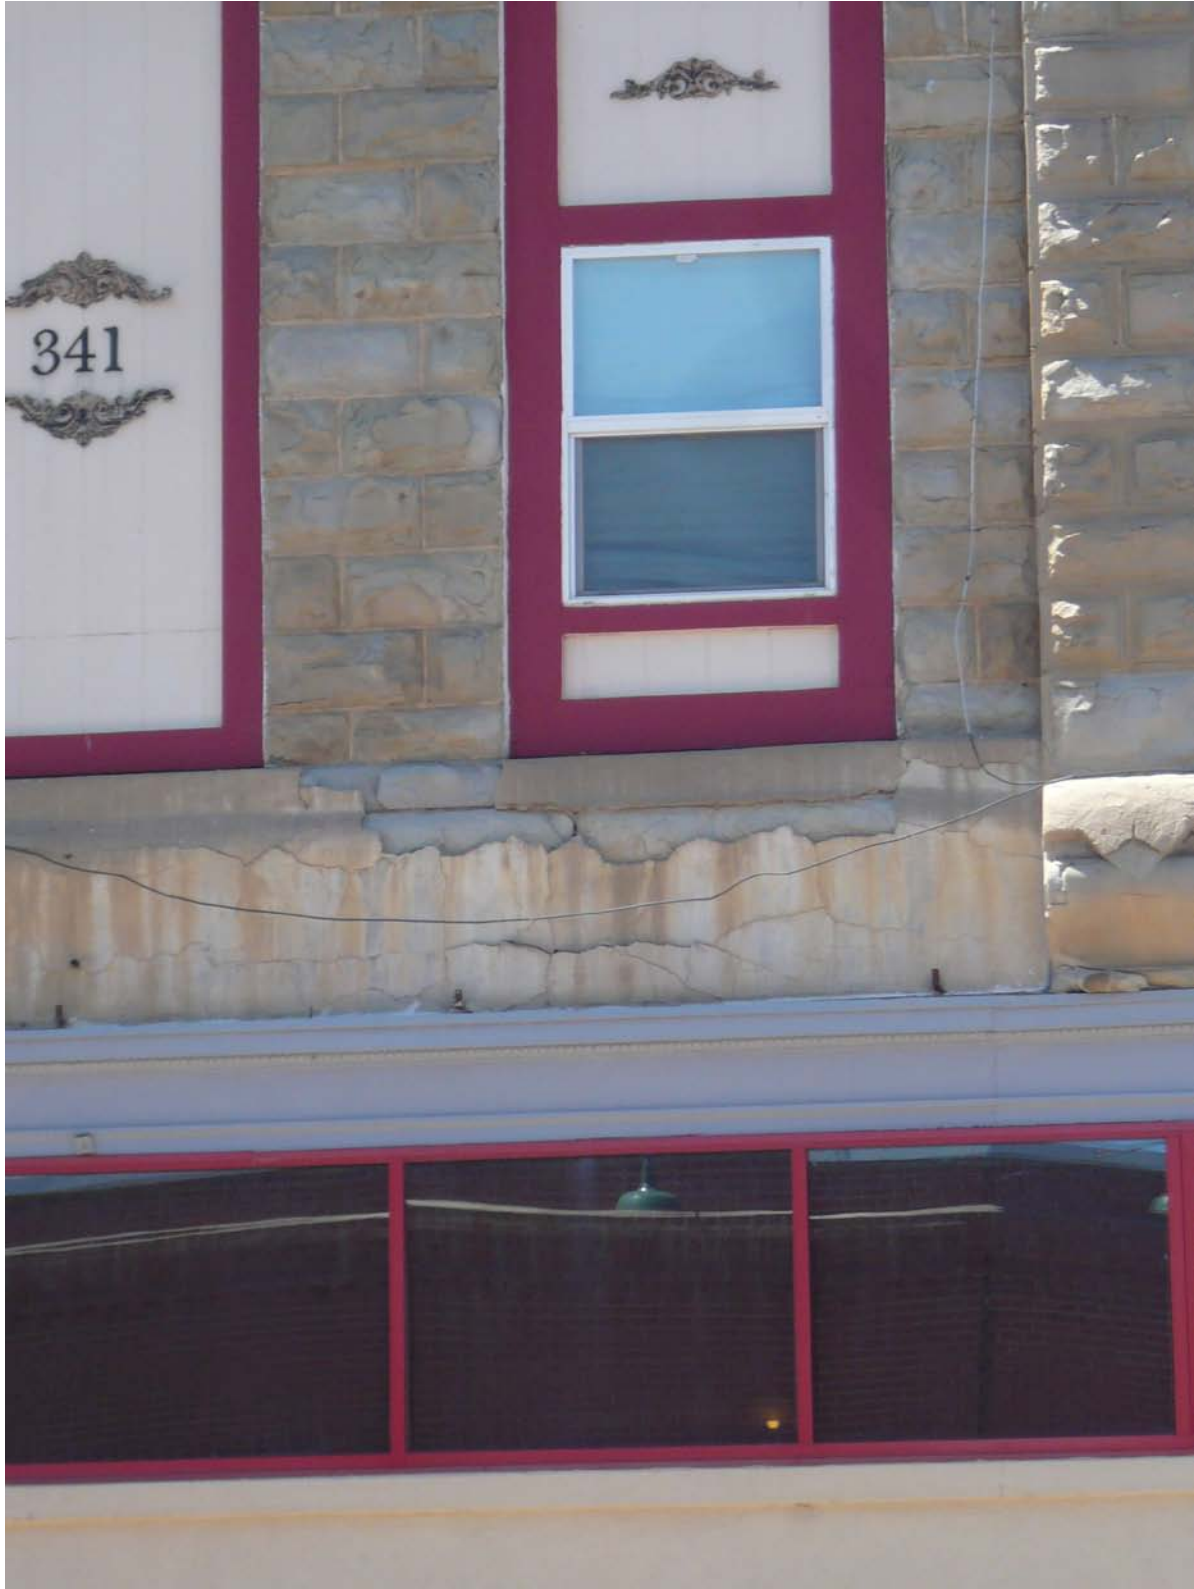
The “What a Grind” coffee shop had plaster and metal siding fall from the front of the building (Figure 22).

Figure 22. Plaster and metal fell from the outside of the “What a Grind” coffee shop in Trinidad, CO.
