East Fork Landslide Report May 18, 2008

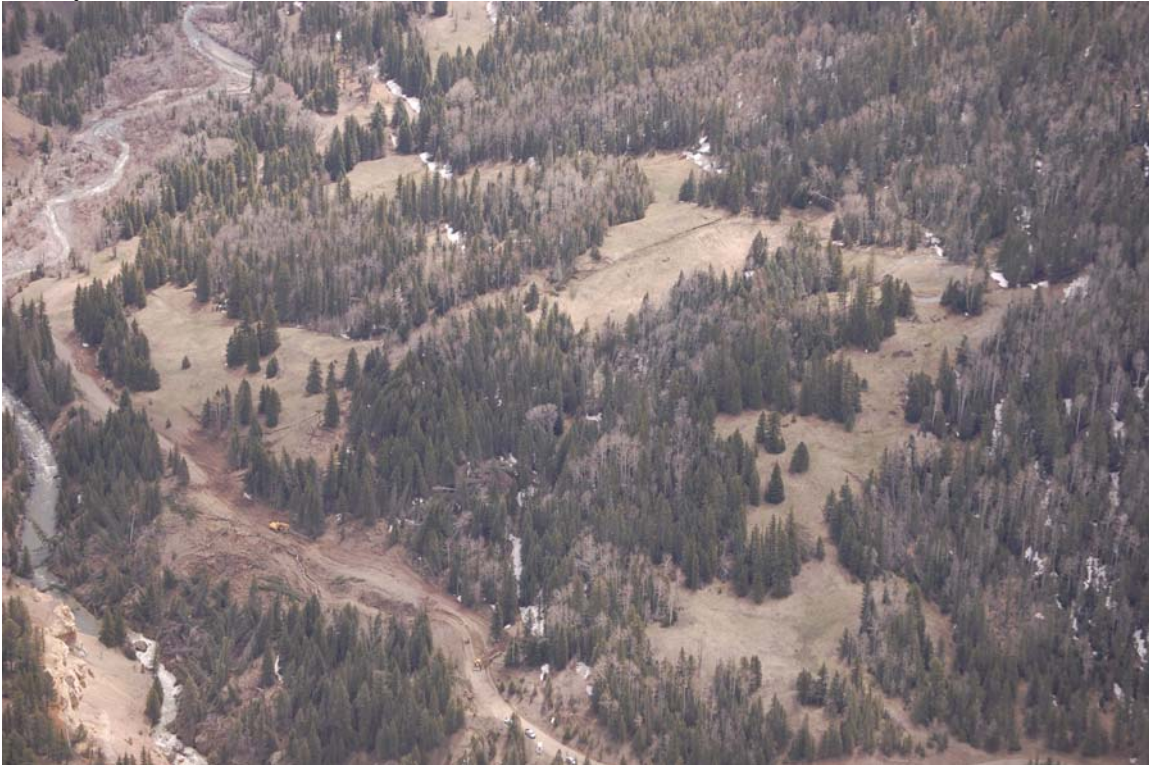
Figure 1. Eastward looking view of the East Fork Landslide showing the Forest Service Road, Excel Energy pipeline right-of-way, and the constriction of the river.

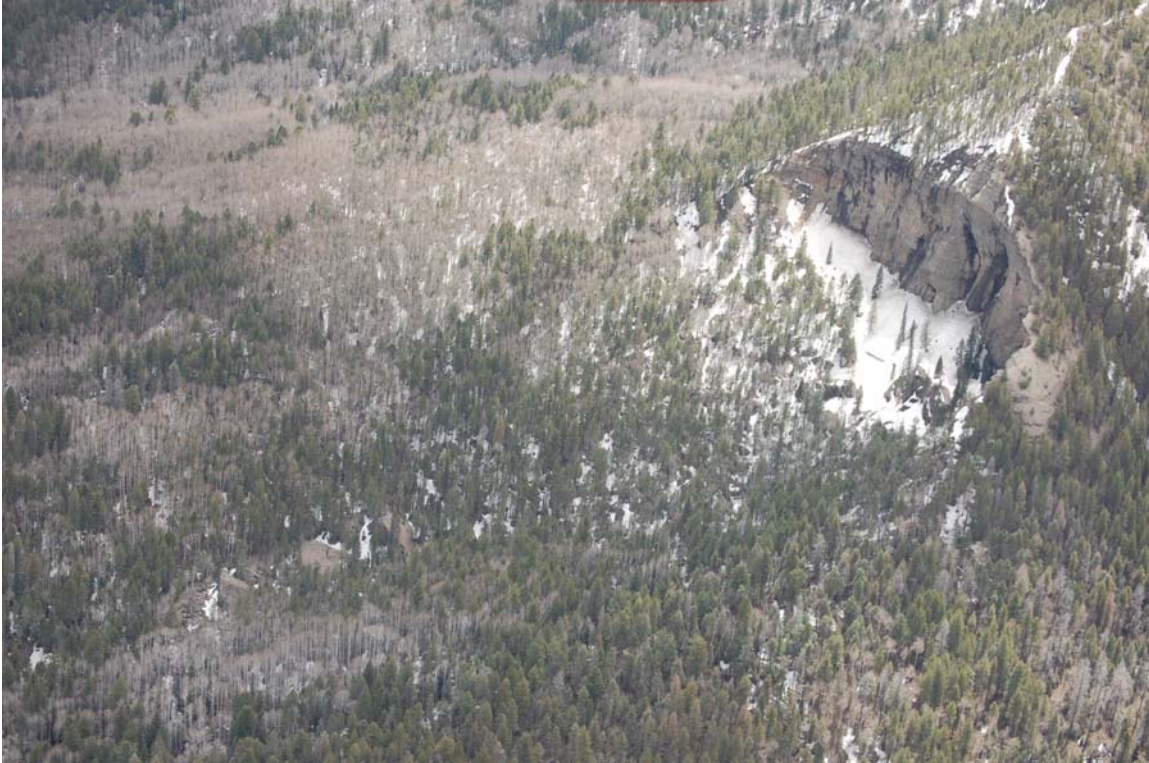
At 3:00 PM OEM held a conference of pertinent emergency personnel for Archuleta Co. Over 40 people were in attendance including several from the State of Colorado in Denver on the phone. During this meeting Mr. Carroll discussed the geologic aspects of the landslide based on the overflight. An initial report indicating that about 35 acres were involved in the active landslide was confirmed. But the active landslide is just one within a larger complex of older earthflow-type landslides on the hill covering approximately 350 acres. The older landslide goes uphill toward a 300 ft high head scarp of volcanic bedrock (Figure 2).

Figure 2. Upper head scarp of an ancient landslide above the 350-acre landslide complex. This cliff is not immediately connected to the highest scarps of the active landslide, but is separated by about ¼ mile of rockfall debris, mostly still covered by snow in this photo.

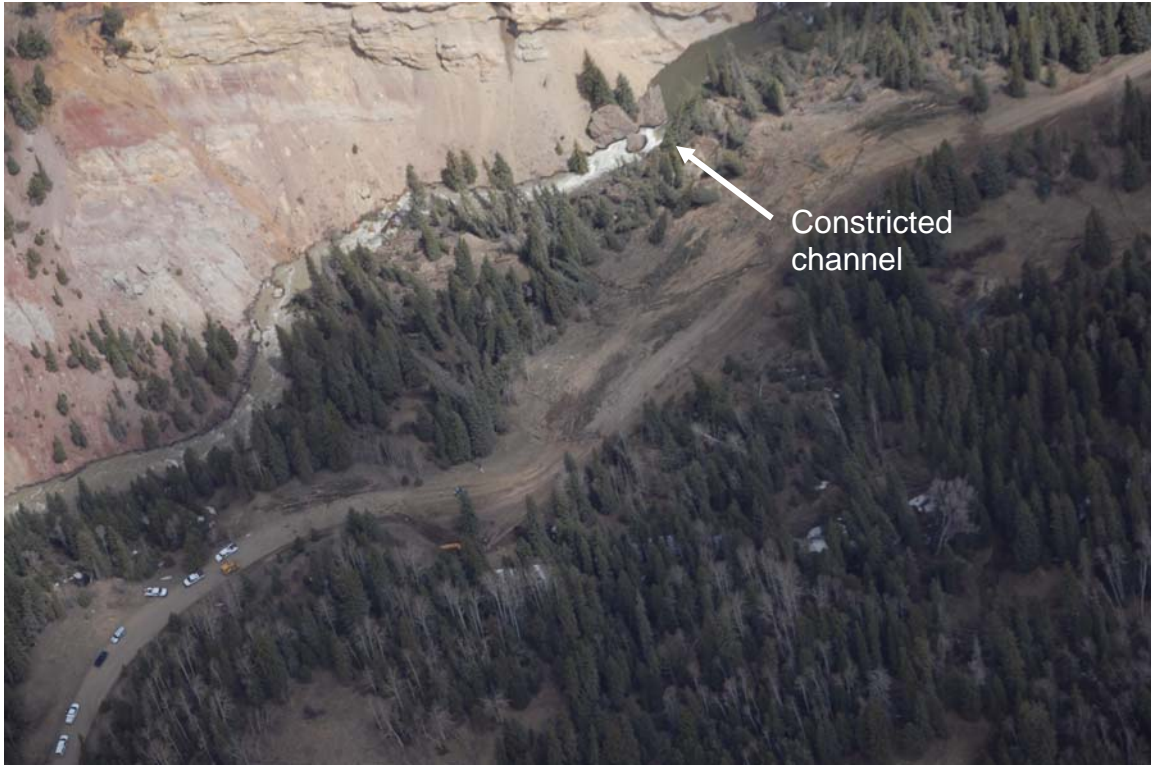
It is evident that the landslide toe is pinching the East Fork of the San Juan River. A large boulder constricts the channel forming a small dam and creating a wider river width for about 100 ft long upstream (Figure 3). This channel constriction is certainly caused by the landslide as it is an area of the toe with newly downed trees. This constriction may have been present before the current episode of movement due to previous landslide activity. The widened portion of the river could be an incipient “lake” and bears watching.

Early reports estimate that the landslide moved 50 ft horizontally toward the river within the first 10 days of May 2008. If the slide moves at that rate into the East Fork, it could potentially block the river, but it depends on the ability of the river to remove the dirt and rocks being pushed into it by the landslide. This location is 12 miles upstream from the town of Pagosa Springs, hence the emergency situation. Excel Energy has been monitoring the slide with surface stakes and lath, and at last measurement the landslide moved toward the creek 3.3 ft in 20 hours time as measured by the US Geological Survey May 15-16.

Figure 3. Aerial view of the landslide toe affecting the East Fork of the San Juan River. Note the cliff-face across the river exposing Tertiary Volcanic bedrock.

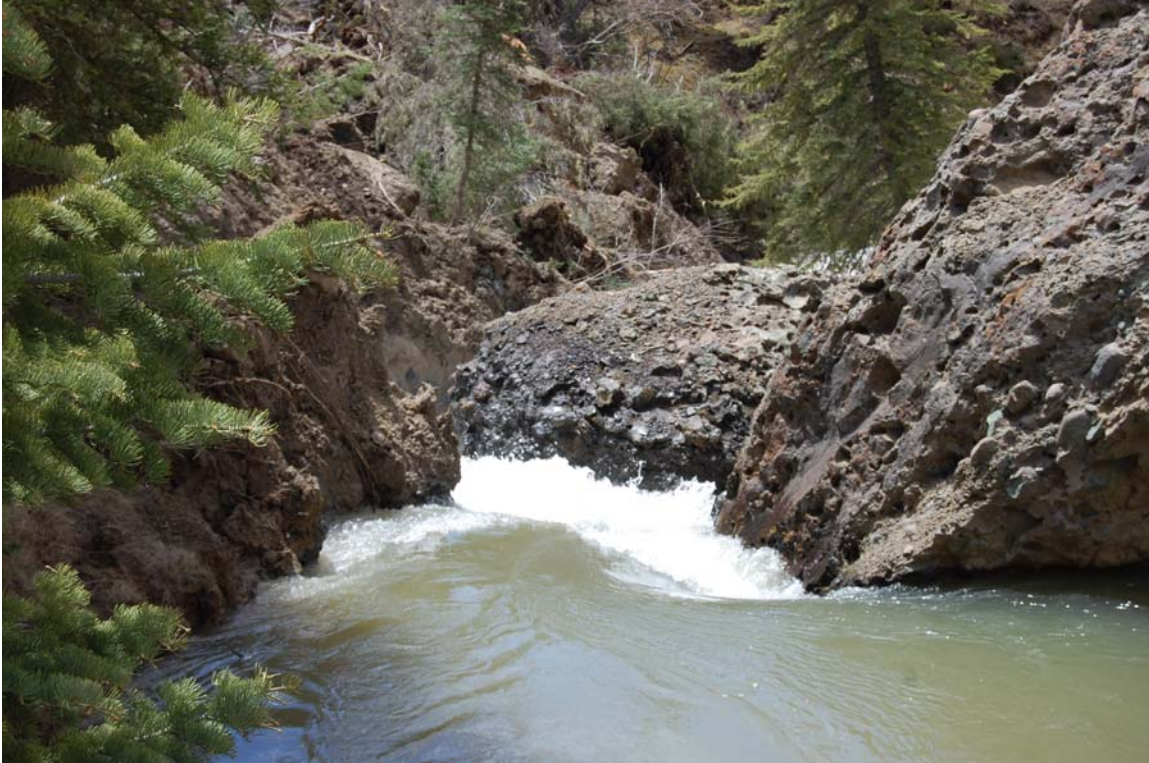
On May 15, 2008, Mr. Carroll conducted a field investigation on the ground at the landslide complex. To gauge movement of the slide in the widened channel portion, five stakes were installed into the toe of the landslide complex 1 ft above the “lake” level. Access to the stable north side of the slope was not possible. Large boulders of volcanoclastic conglomerates partially block the river channel forming a cataract (Figure 4).

Figure 4. View looking downstream from the small-impounded “lake” through the constricted zone. Landslide toe is on the left. Conglomerate boulders on the right are typical of the bedrock in nearby cliffs about 200 ft higher than the strata observed in the north side of the river channel.

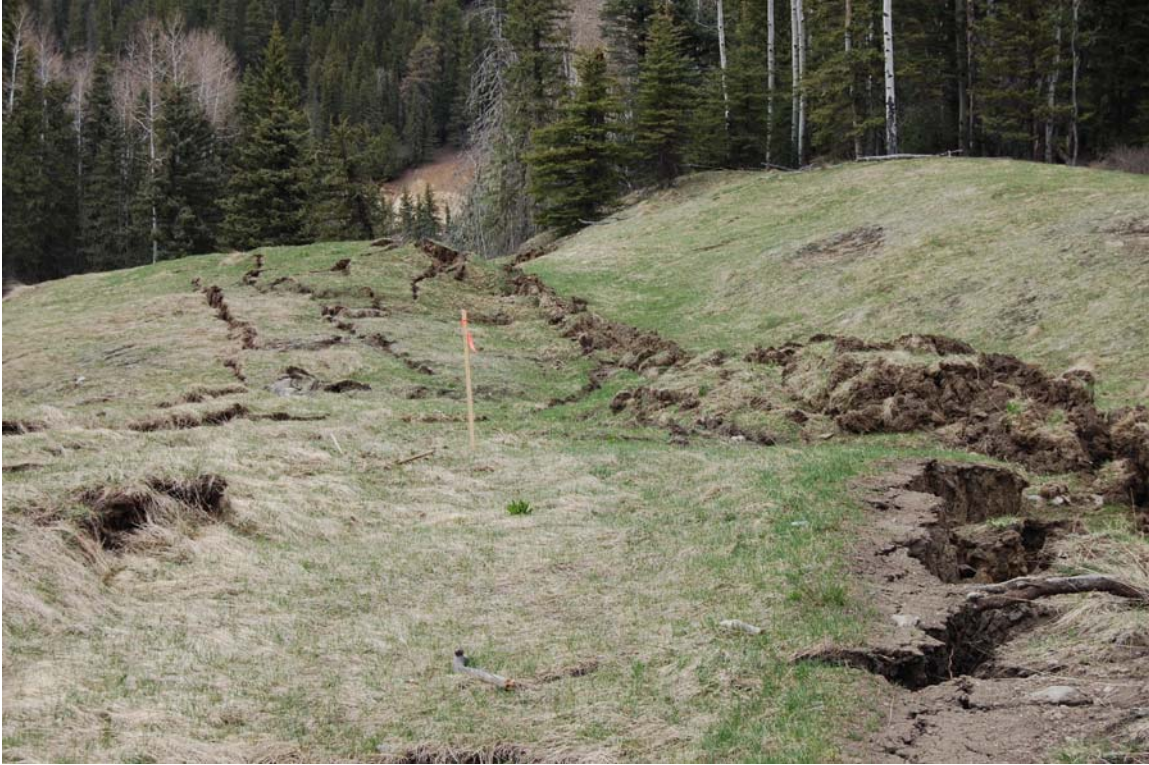
Excel Energy maintains a major natural gas pipeline in the East Fork Valley. This pipeline was compromised on May 2 during the initial landslide movement. An Excel Energy geotechnical geologist is monitoring the landslide for additional movement with a series of 50 lath markers (Figure 5) situated along the USFS road across the toe of the landslide. They noted that the slide has moved 50 ft horizontally in two weeks time. Excel has responded by excavating the 8-inch pipeline and replacing it with an above ground flexible 4-inch line that can be moved uphill daily.

Figure 5. Lath marker in a meadow area along the east shear ridge that marks the eastern extent of the current landslide. A pressure ridge to the right is part of an older landslide that previously buckled the land surface. View is downhill toward the river.

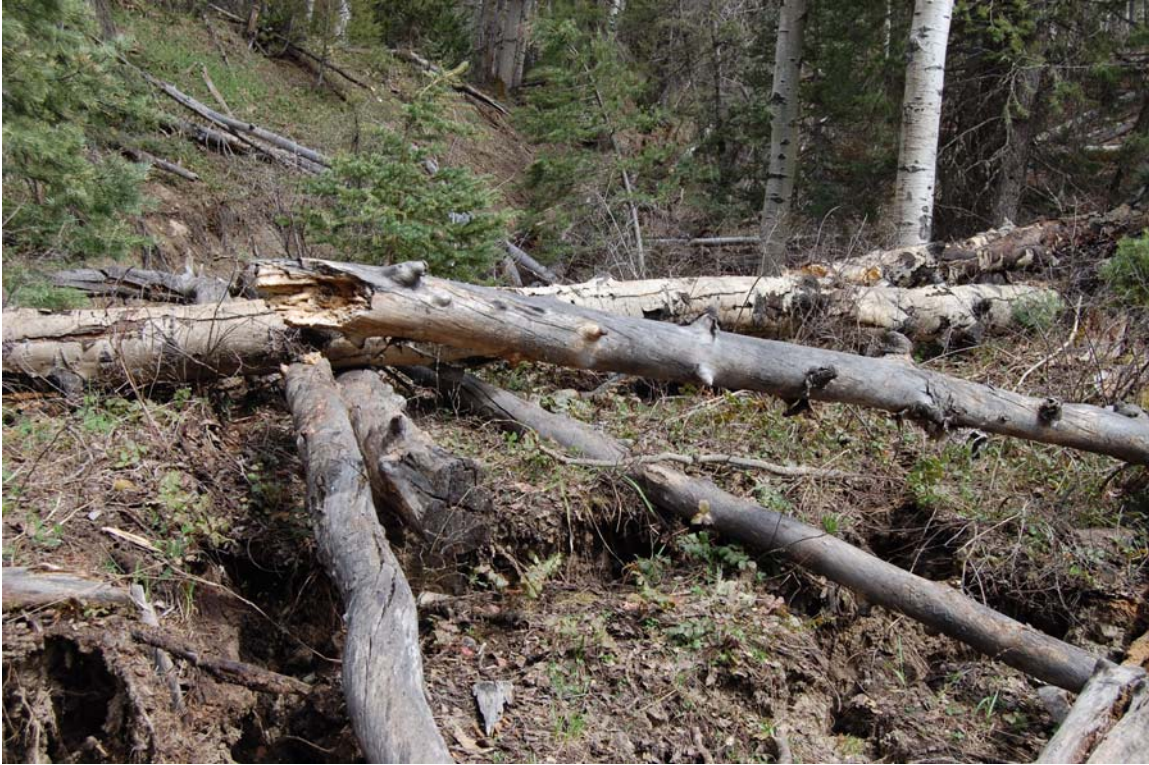
The middle section of the landslide consists of extensional land features that have pulled the surface apart in dramatic fashion. The aspen and conifer trees in the area are severely stressed and ripped out in many places. Trees lean at various angles due to the 4 ft to 24 ft high land surface displacements. This part of the landslide is difficult to traverse (Figure 6). The orientation of the scarps trend north-south parallel to the eastern lateral shear, changing to east-west higher on the slope nearer the headwall scarps.

Figure 6. Small scarps within the upper to middle sections of the landslide show extension features pulling apart the surface terrain. Some scarps are up to 24 ft in height. Both live and dead trees have been twisted in this area. Small sag ponds impound water in this area also, especially along the main creek channel.

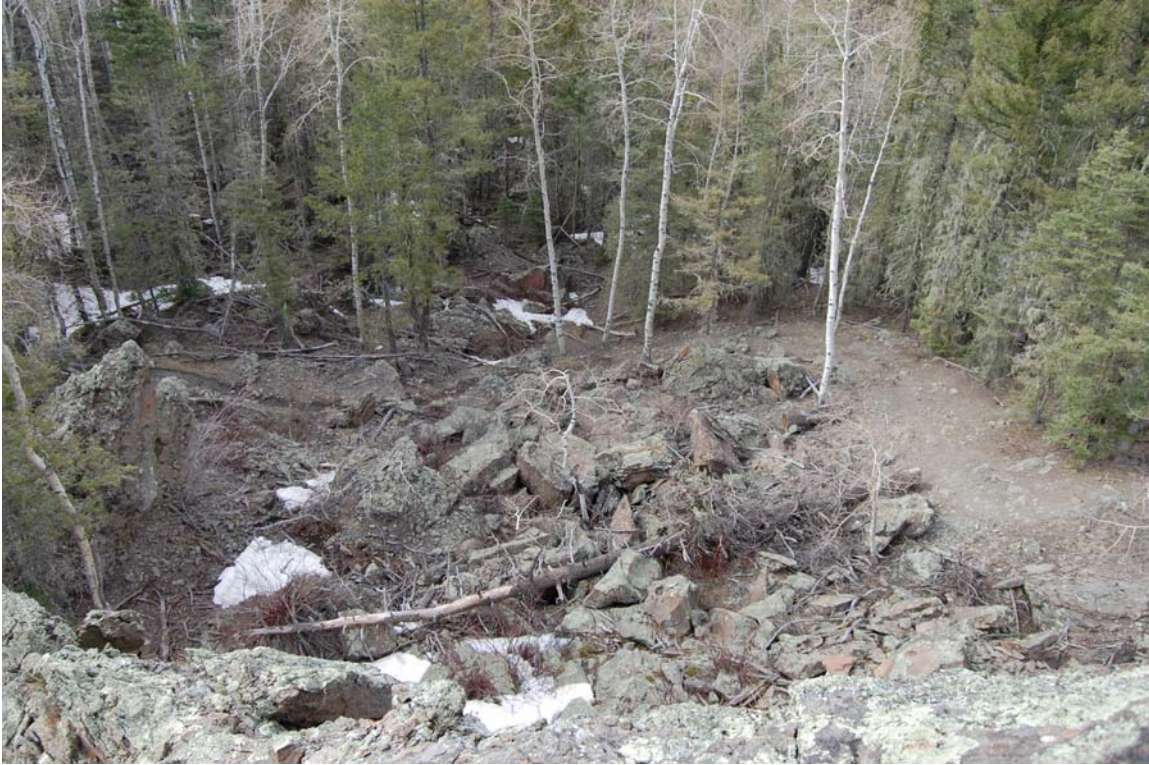
The upper part of the landslide consists of at least two circular headwall scarps on the east and central parts of the landslide. This area is also located within the South San Juan Wilderness Area. Five stakes were placed above the head scarps to monitor headward or retrograde movement of the headwalls. Stakes were also placed to monitor motion on a major pressure ridge on the east side, and the moving part of the eastern headwall. The highest part of the landslide daylights within the volcaniclastic rockfall debris at the top of the hill (fig. 7).

Figure 7. Rockfall debris along the main landslide creek channel just above the highest head scarp of the recent landslide. This area of volcanic rocks and large house-sized boulders may be periglacial in origin. This basin forms the collection point for all surface water moving through the landslide.

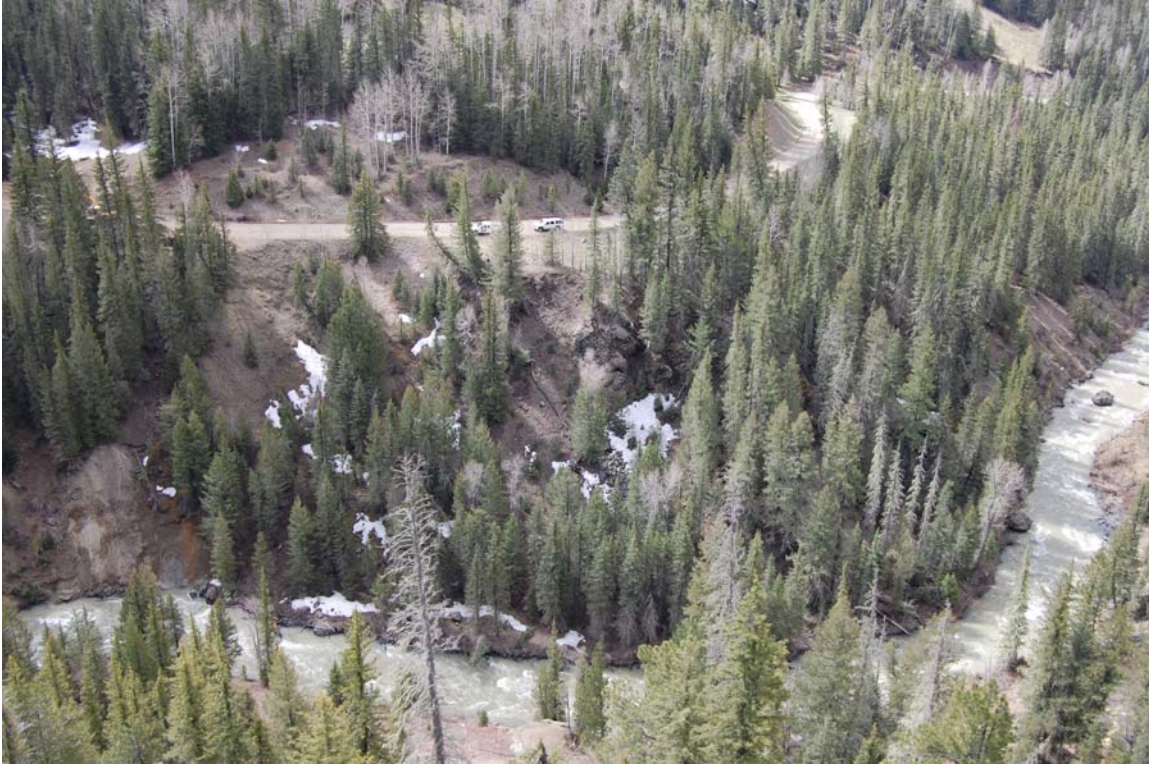
A helicopter overflight (arranged by Archuleta OEM) on May 16, 2008 allowed closer viewing of landslide features. Over 300 aerial photographs were taken of the landslide. From this closer viewpoint one can see all of the features of the landslide including the affected East Fork River (Figure 8). An additional smaller landslide also exists on the north side of the river just downstream from the East Fork slide reviewed in this report.

Figure 8. East Fork landslide toe downriver from the boulder constricted area. The swift moving water flow and steep gradient is assisting in removing landslide debris that moves into the channel. Left edge of the photo is on the active landslide and the cars are located on the USFS road just west of the active landslide on older landslide material.

The landslide toe juts out into the river. It is not clear whether the basal glide plane daylights at the surface or not, but it is clear that the entire tree covered toe that extends out into the river is moving. If the steep gradient of the river with high water velocity can erode the soil, rock, and trees that are being pushed into it, then the dynamic system will remain in balance. If the weather becomes wetter, or the oncoming snow runoff induces increased landslide movement, then the river may become more constricted. It will take a considerable amount of force to block the channel and for now the river seems to be able to erode the landslide toe. But the next four weeks during the peak runoff will be critical for monitoring the situation.

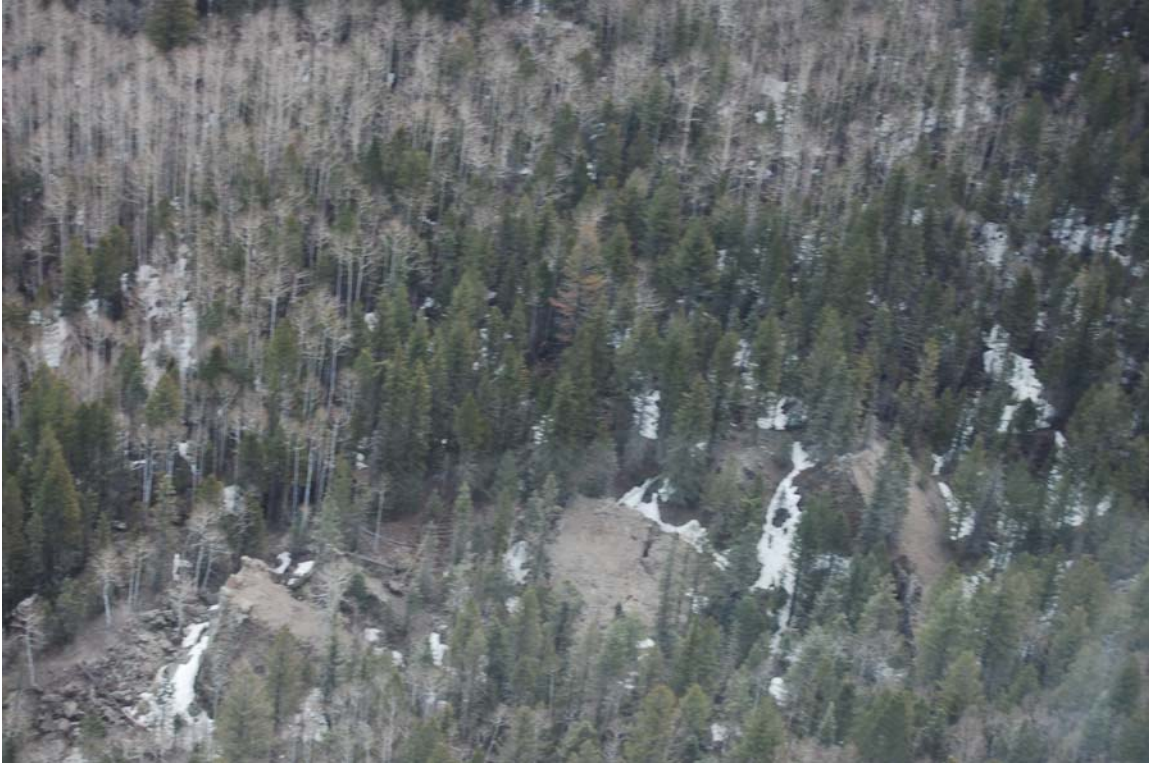
Figure 9. Aerial view of the rockfall channel just above the recent landslide. The main surface drainage for the landslide goes through this area and is still somewhat snow covered. Large vertical cliffs are uphill from this point by ¼ mile. This area is a large collection point for water and is very well shaded by the cliffs.

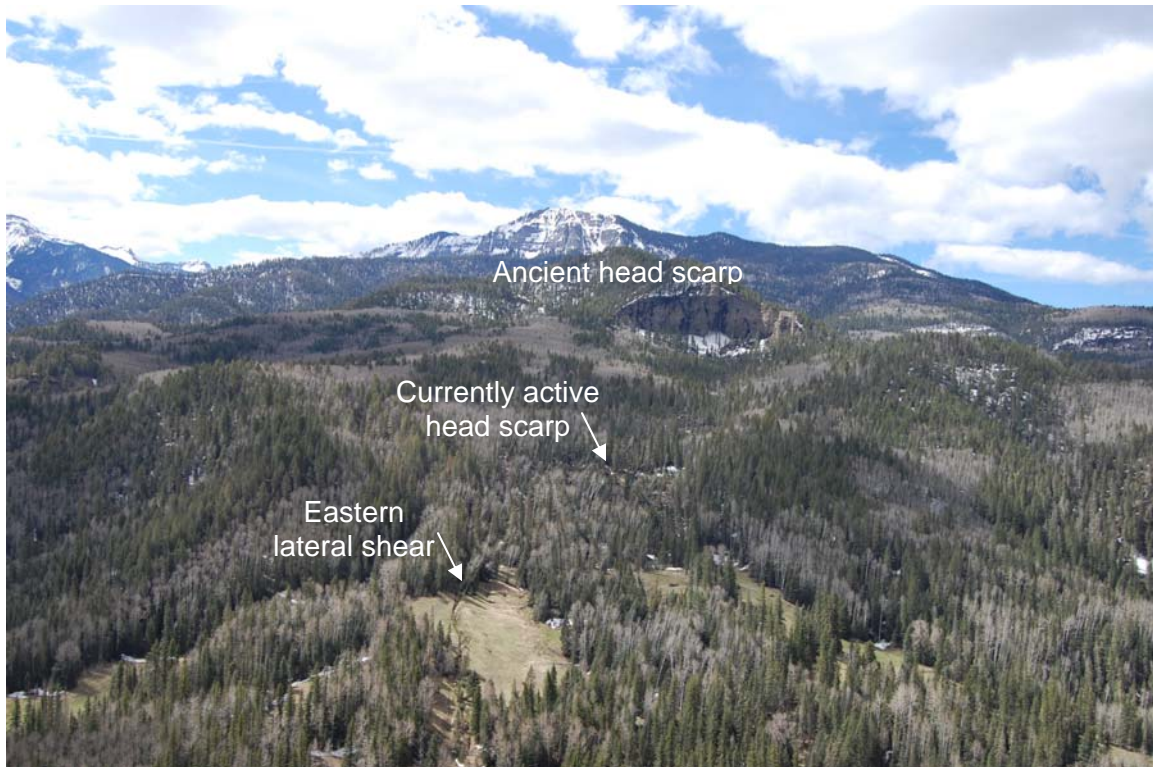
After reviewing all of the data it seems clear that this partial reactivation of an older, large landslide complex (Figure 10) is a threat to the East Fork of the San Juan River. Movements recorded so far indicate that the landslide has the potential to block the river channel for up to 600 ft in length. Immediate monitoring should be conducted. The USGS geologists suggested this to the Archuleta County OEM, but OEM only has so

Figure 10. Aerial view of the middle and upper part of the ancient (older) and active landslides. The eastern shear fault is visible in the meadow. Downed aspens uphill from there show the distressed extensional rotation areas, and the cliff face in the background shows the ancient head scarp and rockfall debris area.

many resources. Since the area is somewhat remote it is suggested that satellite monitoring of electronic distance measuring devices be installed to relay data back to the office to warn about catastrophic failure.

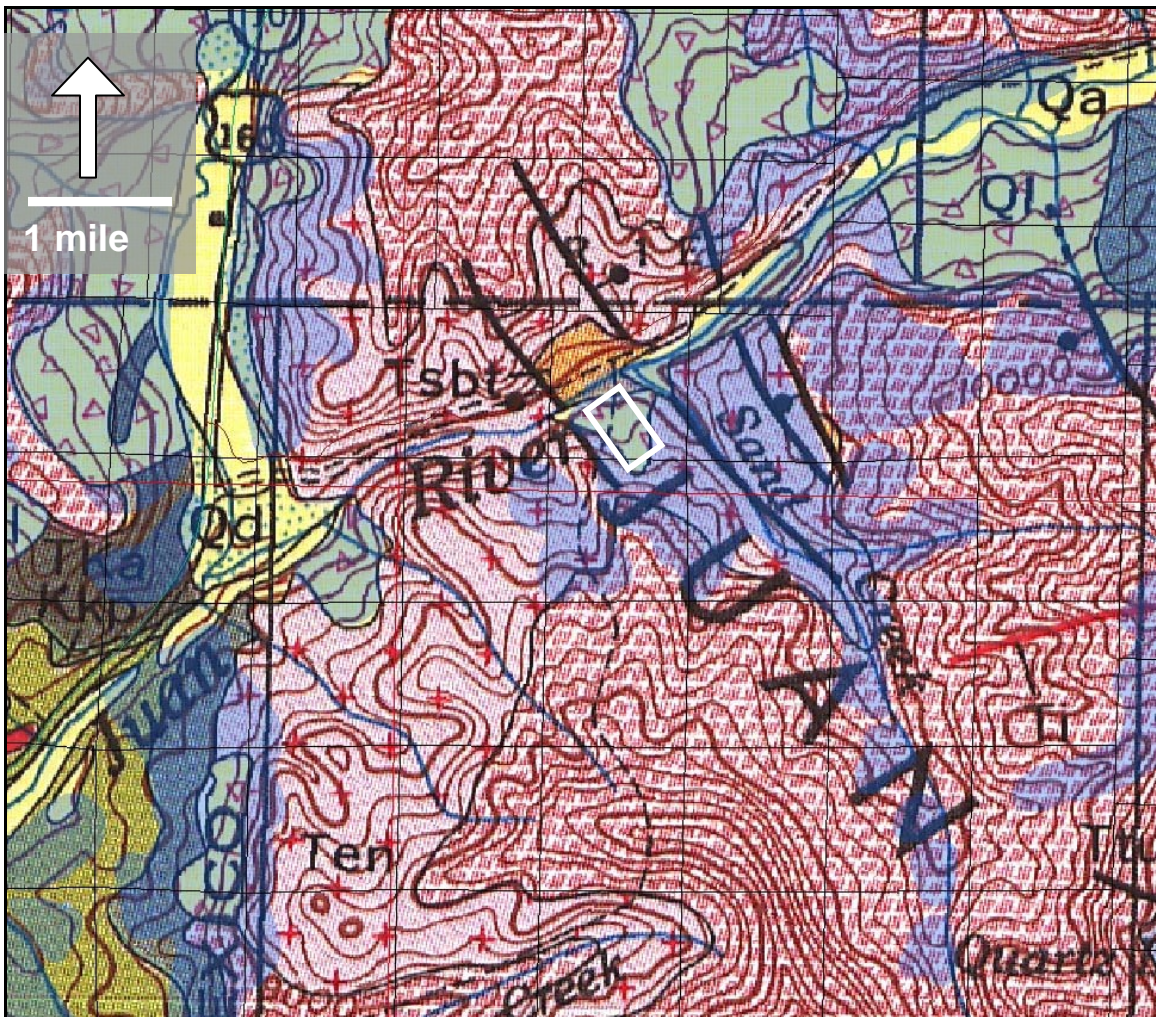
Figure 11. Geologic map of the East Fork landslide area. Green and blue shaded areas are mapped landslide terrain. Pink areas are volcanic rocks. Bold black lines indicate faults with bar and ball on downthrown side. (Steven and others, 1974, USGS Map I-764; Colton and others, 1976, USGS Map I-964)

The East Fork San Juan River drainage basin contains abundant landslide terrain (Figure 11) and the current reactivation constitutes only a small part of a larger landslide complex. The landslide is bounded on the east and west by faults trending north-northwest. Sand Creek follows the trace of the fault on the east side of the current landslide.
